# 2018 Adirondack Aquatic Invasive Species Surveys

## *Early Detection Team Report*

Ezra Schwartzberg, Ph.D., Janelle Hoh and Zoey Varin

Adirondack Research

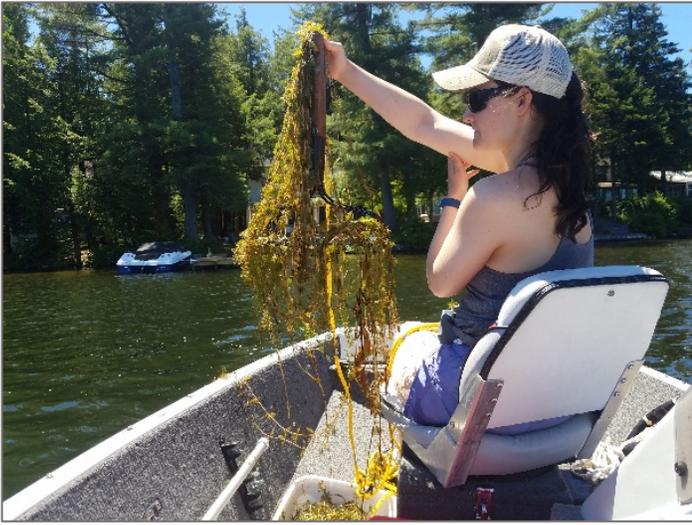
*Photo 2 (above):* Field Assistant Zoey Varin retrieving a rake toss from East Caroga Lake, Fulton County.

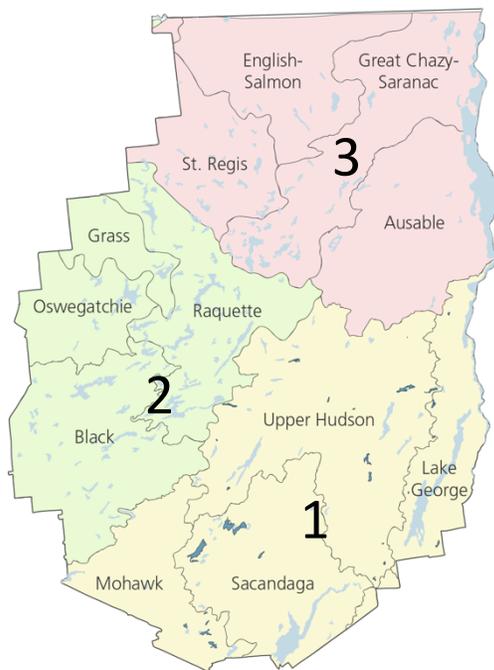
*Figure 1: Regions of yearly AIS survey programs.*

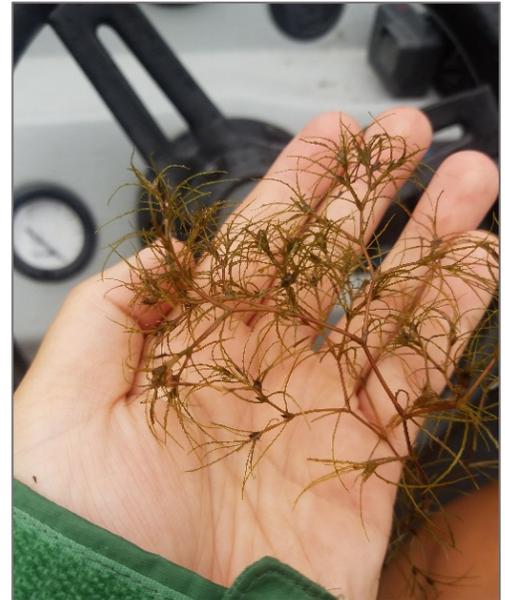
*Photo 3: Invasive brittle naiad found in Hadlock Pond, Washington County.*

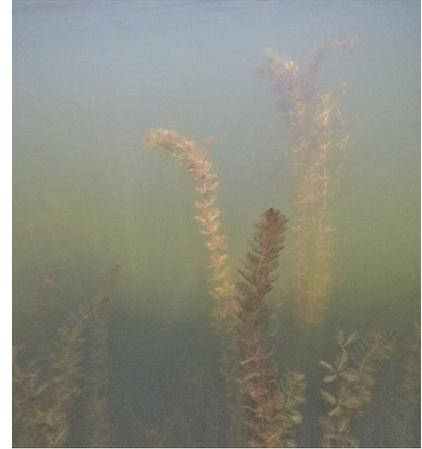
**Photo 4:** A Eurasian watermilfoil bed in Bartlett Pond, Essex County in 2018.

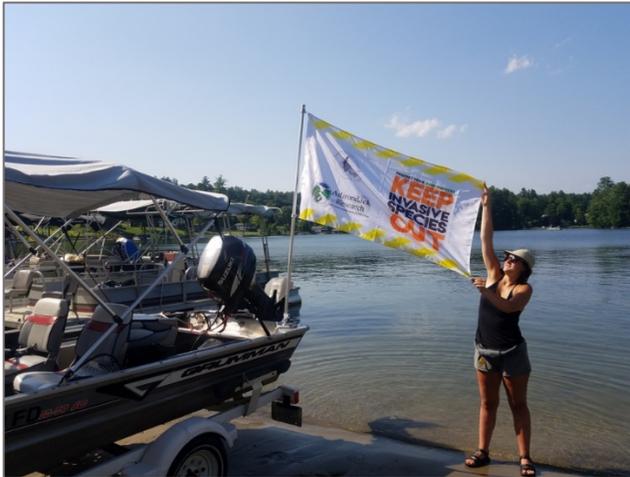
*Photo 5: Crewmember Zoey Varin launching the boat at Hadlock Pond. The Keep Invasive Species Out flag was useful for letting others on the lakes know why our team was there.*

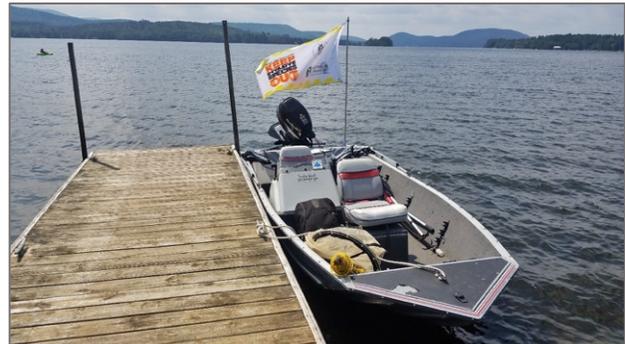
*Photo 7: Our research vessel on Lake Pleasant, Hamilton County.*

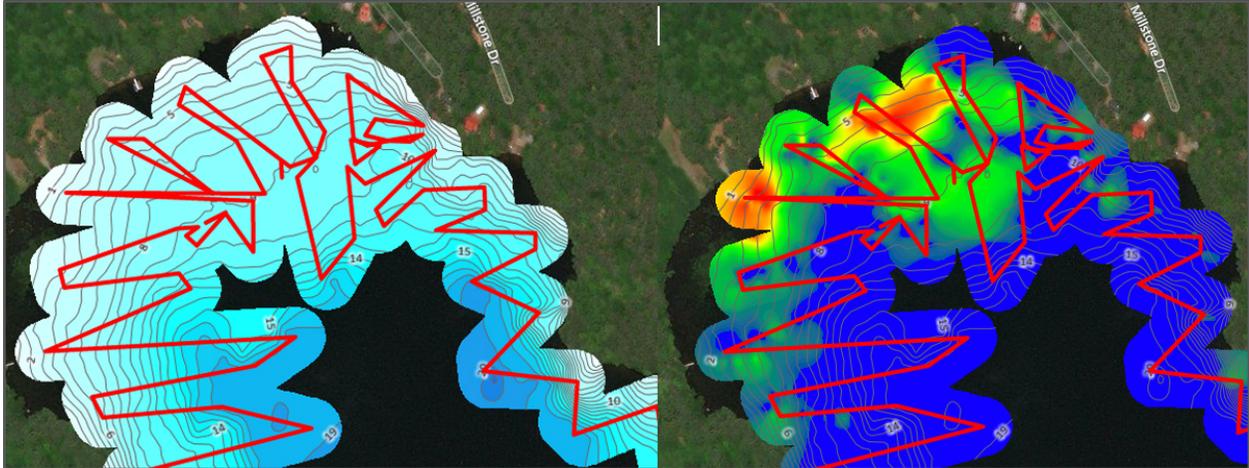
**Figure 2:** Images from BioBase showing the team's track overtop contour lines (left) and biovolume (right). Data represented here were collected from the north end of Friends Lake, Warren County.

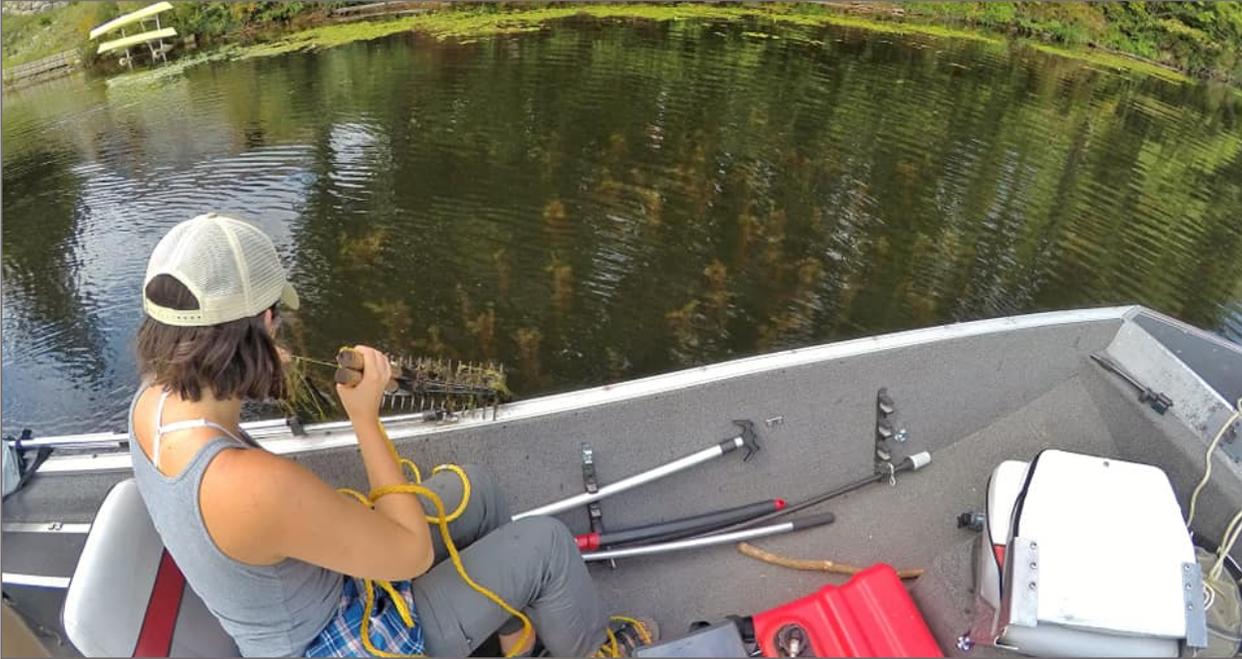
*Photo 10: Technician Zoey Varin retrieving a rake from Lake Algonquin to confirm Eurasian watermilfoil*

Relative percent cover class estimates for each invasive plant bed were recorded in IPMMS using the following ranges: 0, <1, 1-10, 11-25, 26-50, 51-100%. Cover classes are defined in the following table and are based on the scale developed by the U.S. Army Corps of Engineers and further developed by Paul Lord and Bob Johnson from Cornell University

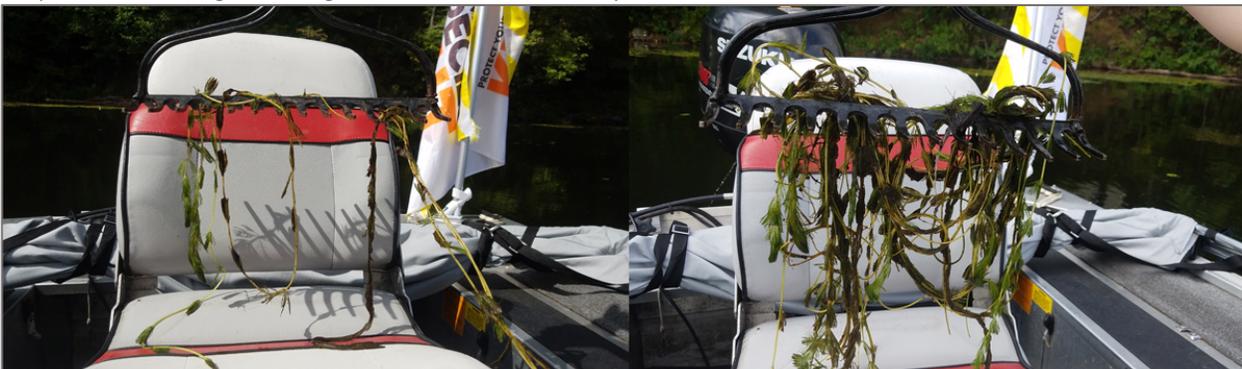
*Photo 11: (Below) Rakes returned with Eurasian watermilfoil from Lake Algonquin, Hamilton County. The image on the left shows 1-10 or sparse and the image on the right shows 11-25 or low density.*

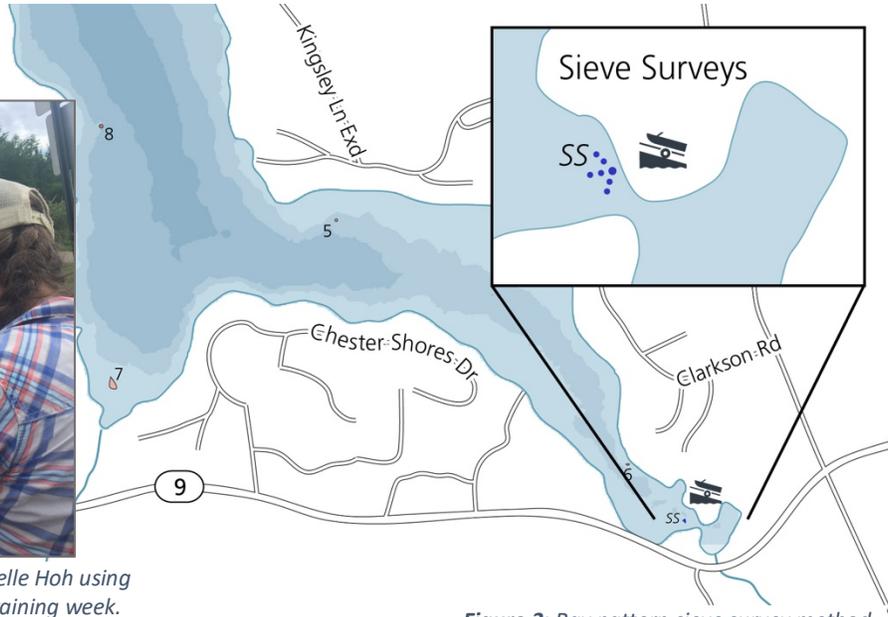
Two methods were utilized to survey for aquatic animal species. 2mm sediment sieves were used at shorelines with coarse, sandy substrates to search for aquatic invasive mollusks. Seven samples were taken at each location using a ray pattern method (See map below and inset).

**Figure 3:** Ray pattern sieve survey method.

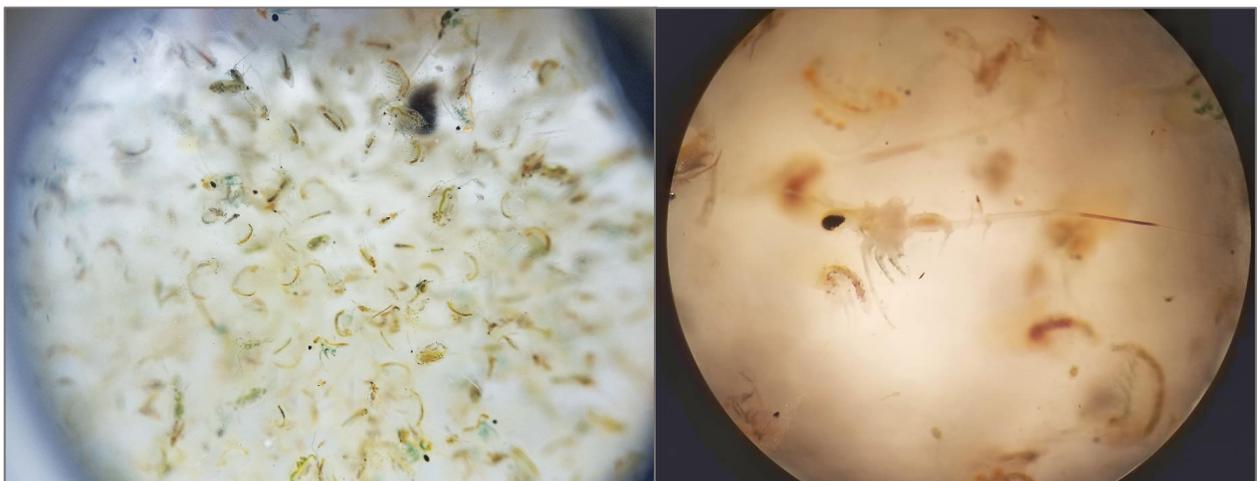
**Photo 13:** A macroinvertebrate sample containing native and invasive species (Left) and a magnified image of the spiny waterflea (Right). Samples are from Sacandaga Lake, Hamilton County.

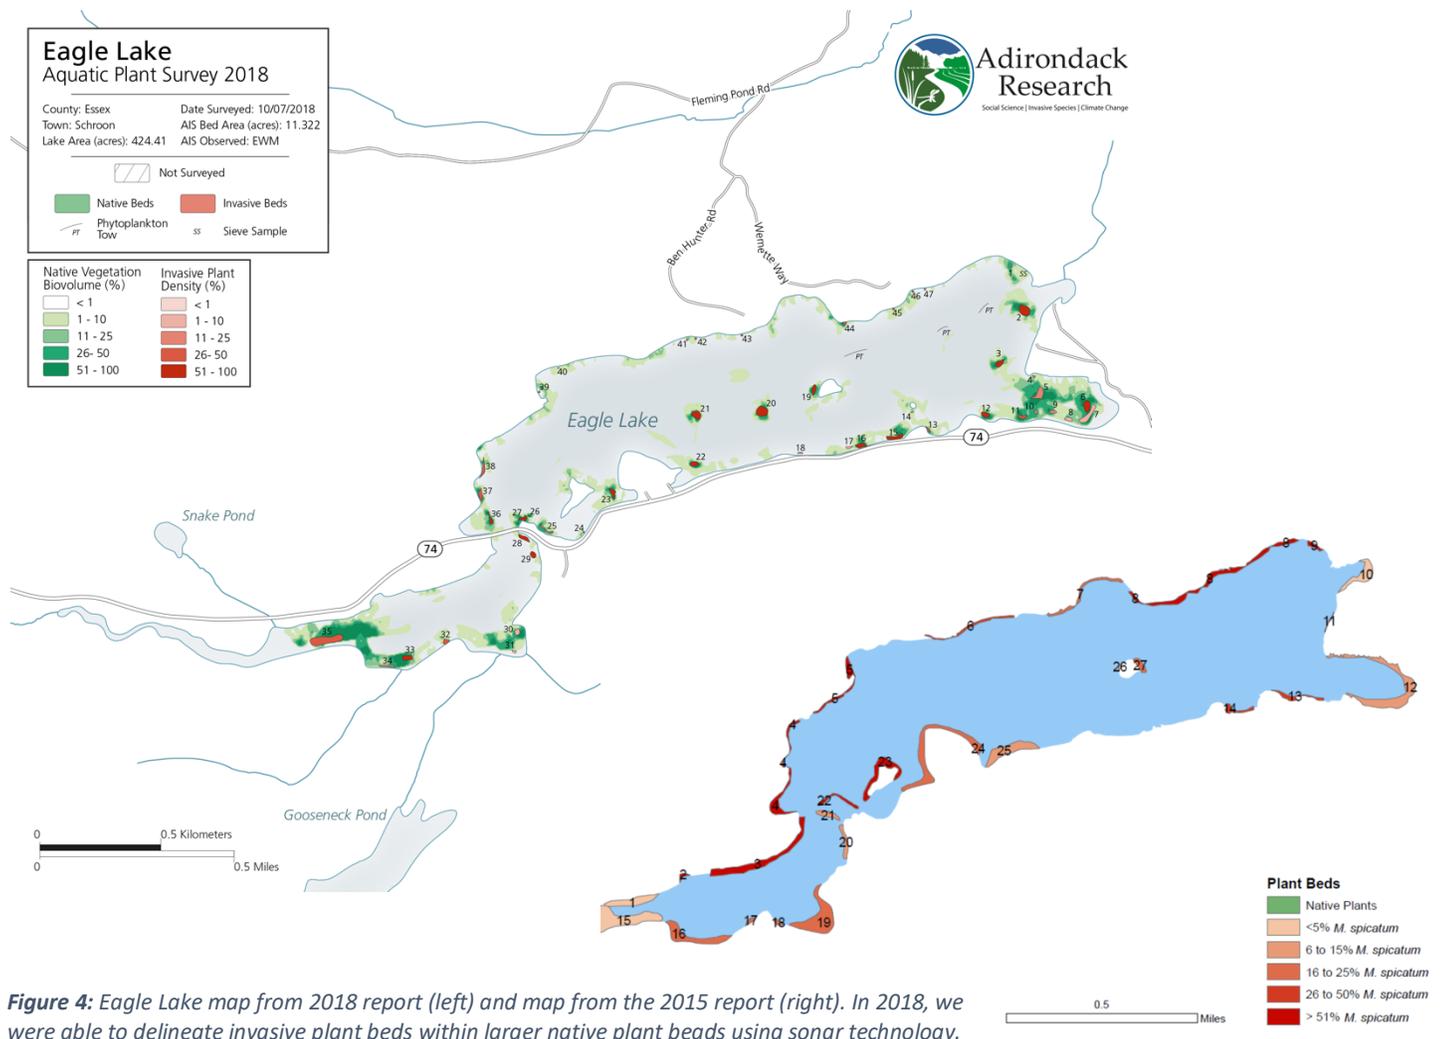
Figure 4: Eagle Lake map from 2018 report (left) and map from the 2015 report (right). In 2018, we were able to delineate invasive plant beds within larger native plant beds using sonar technology.

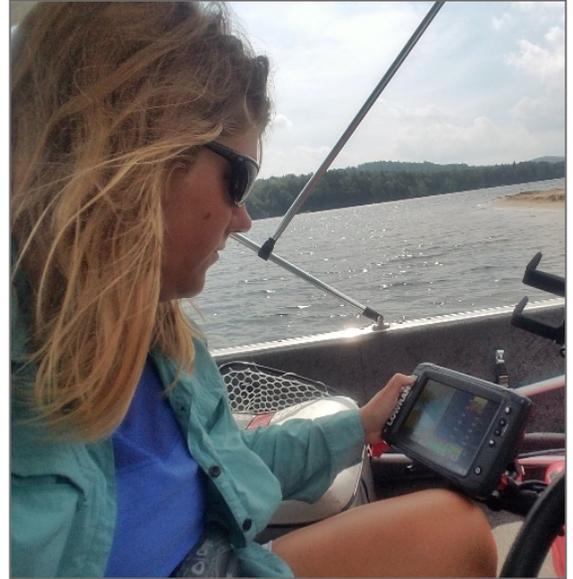
*Photo 14: Janelle Hoh using the Lowrance Chartplotter to monitor lake depth and aquatic plant beds.*
