2003 GPS Survey of Eagle Lake Essex County New York

Baseline study documenting the location and
size of the largest and densest beds of
Eurasian Water Milfoil in Eagle Lake

A Study of Milfoil in Eagle Lake (Summer of 2003)

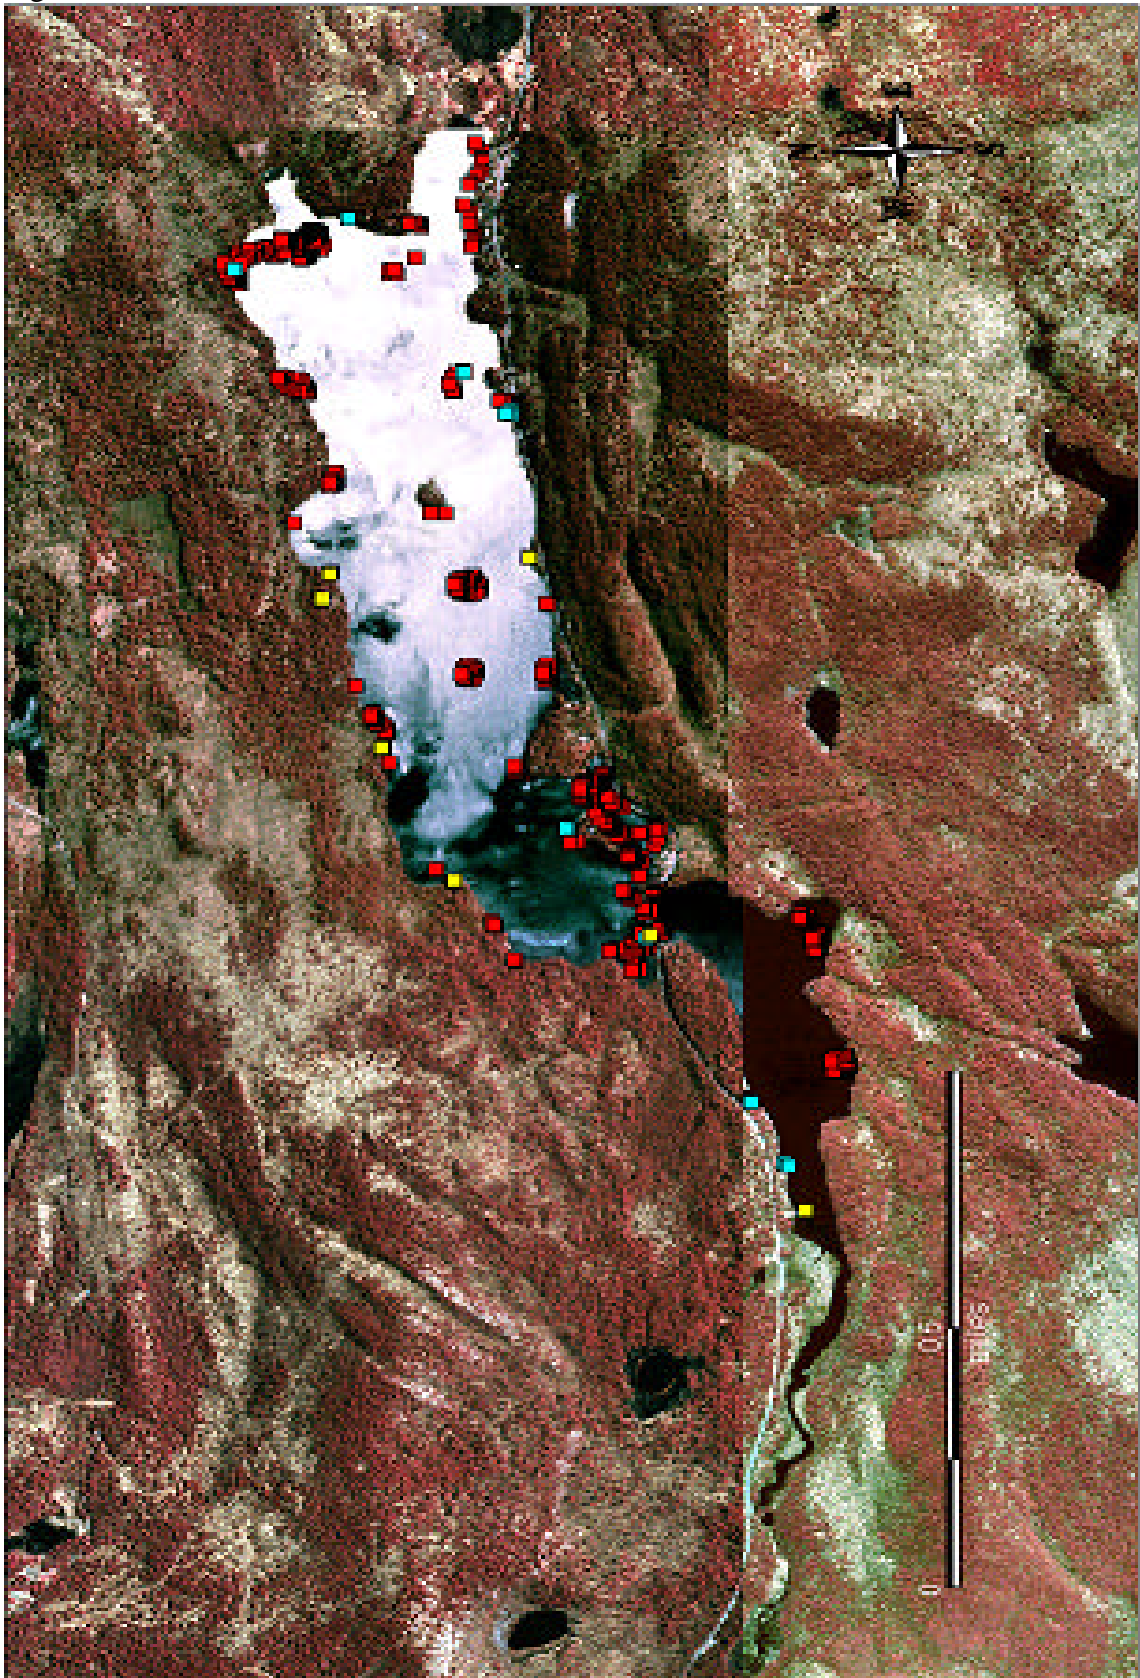
Figure 1

Each red point on the maps represents a point taken along the edge of a milfoil bed, and multiple red points indicate the outline of the patch. Yellow points, indicate a landmark, such as a boathouse, the bridge or the boat launch. And blue points, indicate a milfoil patch that in my opinion is small enough, and lacking sufficient density, so that it is possible to hand-harvest it with a mask, snorkel and dive fins (figures 1-7). It is my suggestion that these patches be addressed as quickly as possible, so as to remove one more breeding ground for milfoil from Eagle Lake.

With this information, we were able to determine, using a built in area calculator and an Excel spreadsheet, that the surface area of Eagle Lake is approximately 412 acres, being composed of approximately 336 acres on the west end (after taking out the surface area of the 3 islands) and 76 acres on the east end. It was also determined that Eagle Lake is approximately 2.7 miles long, and at it’s widest point, is approximately 0.45 miles across. Using the same area calculator, we were able to calculate the surface area of the patches, and then using an Excel spreadsheet to sort the patches based on size, it was possible to determine that Eagle Lake has approximately 8.0 acres of milfoil located in 49 separate locations. This means that the 8.0 acres of Milfoil occupy just under 2% of the total surface area of Eagle Lake (Figures 1 and 2).

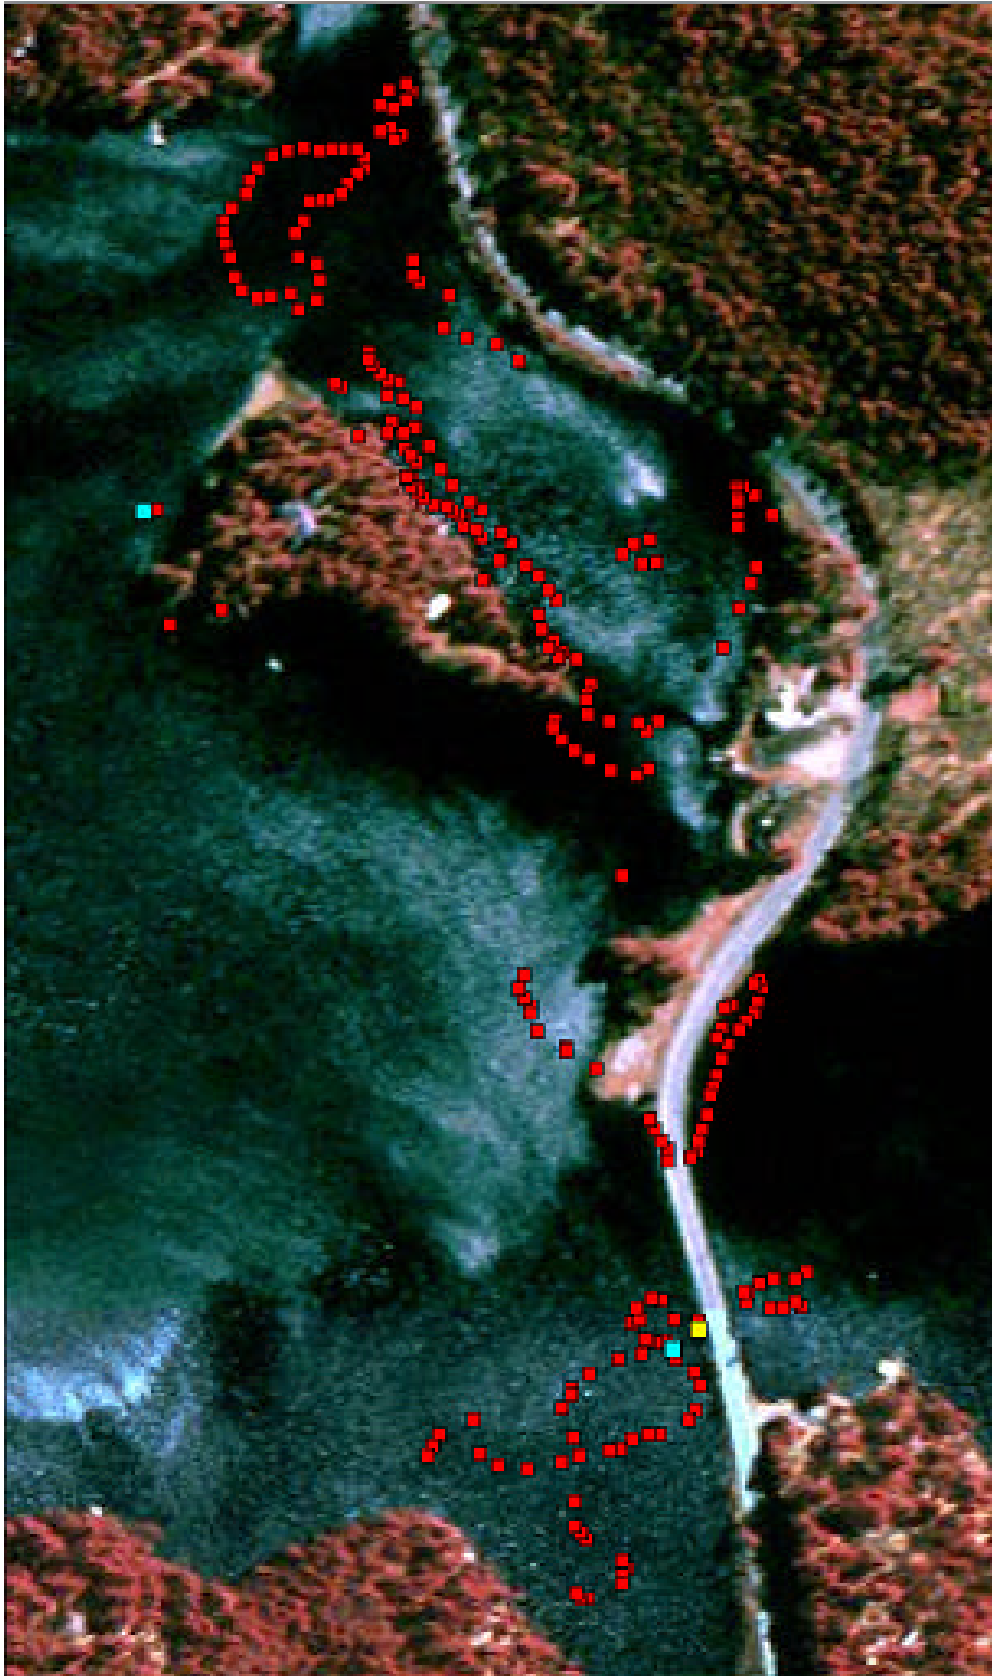
Figure 3

It was also determined, through the use of a Microsoft Excel spreadsheet and the area calculator, the locations of the milfoil beds with a surface area of greater than half an acre. Of the 6 that met this limit, only 1 of them has a surface area greater than 1 acre. These 6 patches however contain 63% of the milfoil in Eagle Lake. Of the 38 other patches, all but 3 of these were smaller than ¼ of an acre. However, it is interesting to note that of the 23 patches that were large than 100 square feet, 10 of them are located around Fox Island and the causeway, where milfoil was originally found in Eagle Lake (Figure 3). This means that the concentration of milfoil in the area between Fox Island, Route 74, and the Causeway is 6 times greater than it is in Eagle Lake as a whole. The percentage of Eagle Lake being covered by Milfoil in this portion of the Lake is just under 13% of the surface area. It is also interesting to note that this is also the location of 2 of the patches that are larger than 1/2 half an acre in size. An explanation for this may

be that the milfoil, since it was first identified in this area, may be better established than in the other parts of Eagle Lake, as well as it being a relatively wind sheltered area, that allows milfoil fragments to collect, and become established plants.

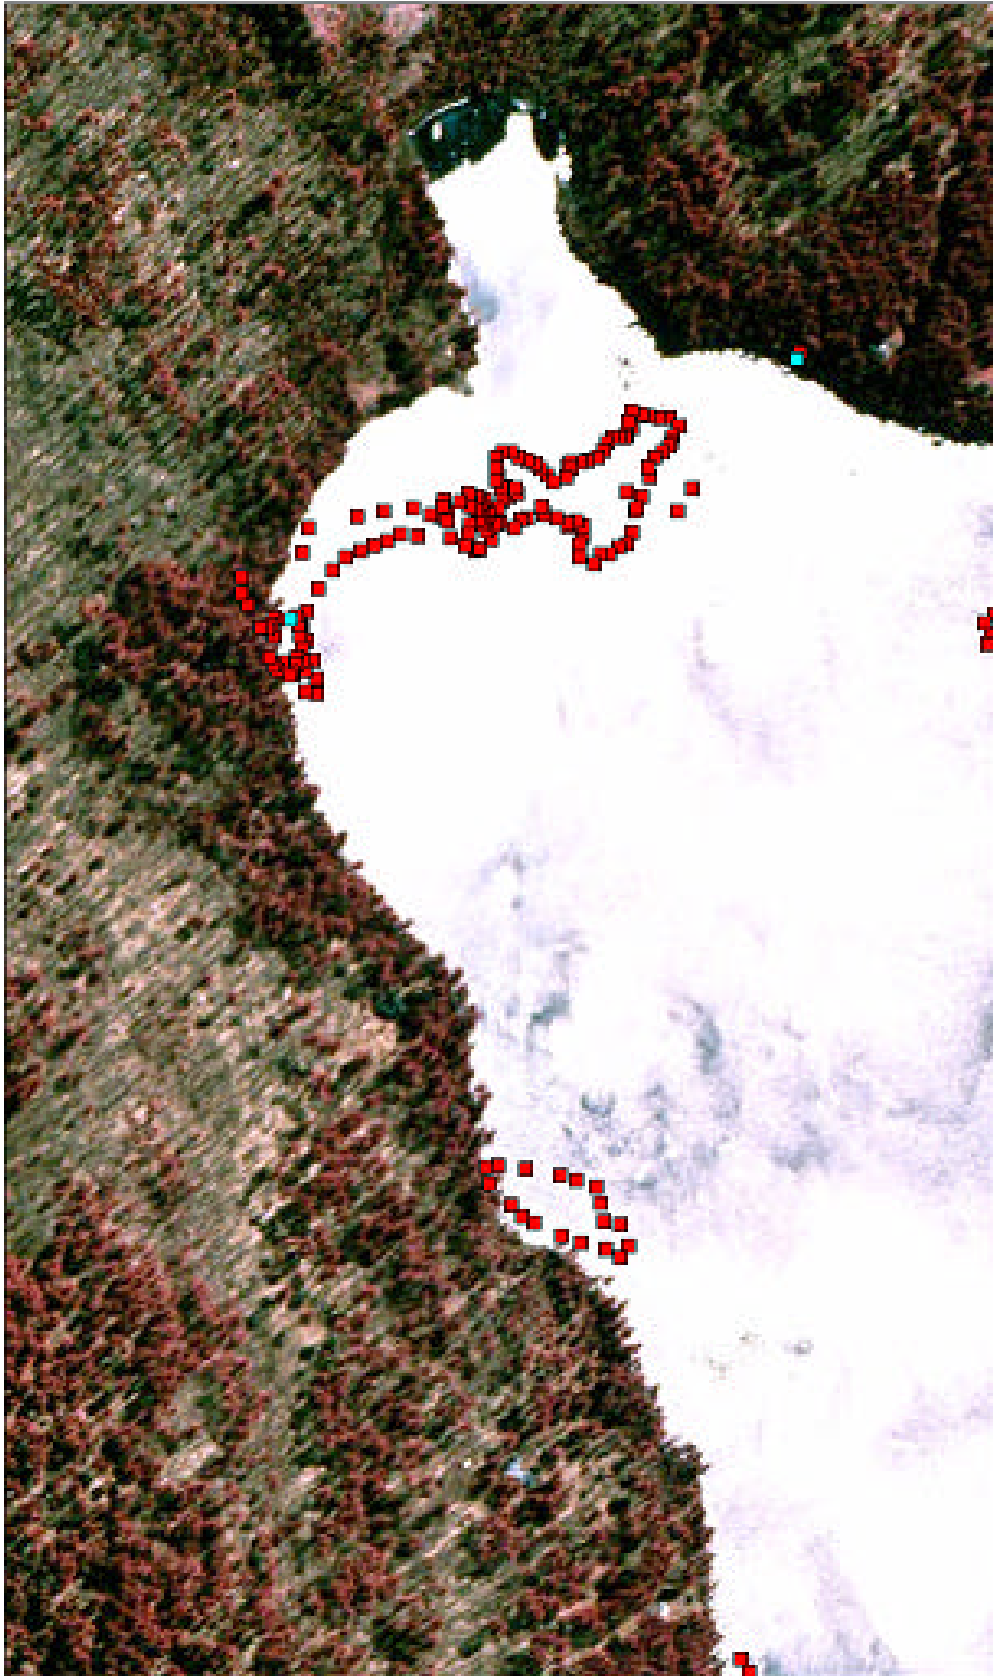
Figure 4

Another section on the Eagle Lake that has a high concentration of milfoil, is Crown Point Beach. This area actually has three patches that are separated by about 10 feet, and stretch from the south side of Crown Point Bay to past Janie Stevens's boathouse (figure 4). However these three separate patches contain 2.11 acres of milfoil, or nearly $\frac{1}{4}$ of the milfoil in Eagle Lake. The other two remaining patches, are the one in the bay between Bob Steven's and Bill Knaus's boathouse and the patch around Sunken Island, with surface area's of 0.70 and 0.59 acres respectively (Figures 4 & 5 respectively). There were no major milfoil patches on the West End of the lake, with the total surface area between the 5 patches, being just over $\frac{4}{5}$ of an acre, as well as the percentage of surface coverage being half the east end of the lake at just over 1%.
