**Final Report**  
**NYS DEC Invasives Species Eradication Grant**  
**State Assistance Contract # C303601**  
***Eagle Lake Eurasian Water Milfoil Eradication Project***  
**Town of Crown Point**  
**Prepared by Rolf Tiedemann**  
**Eagle Lake Milfoil Project Coordinator**  
**January 11, 2011**

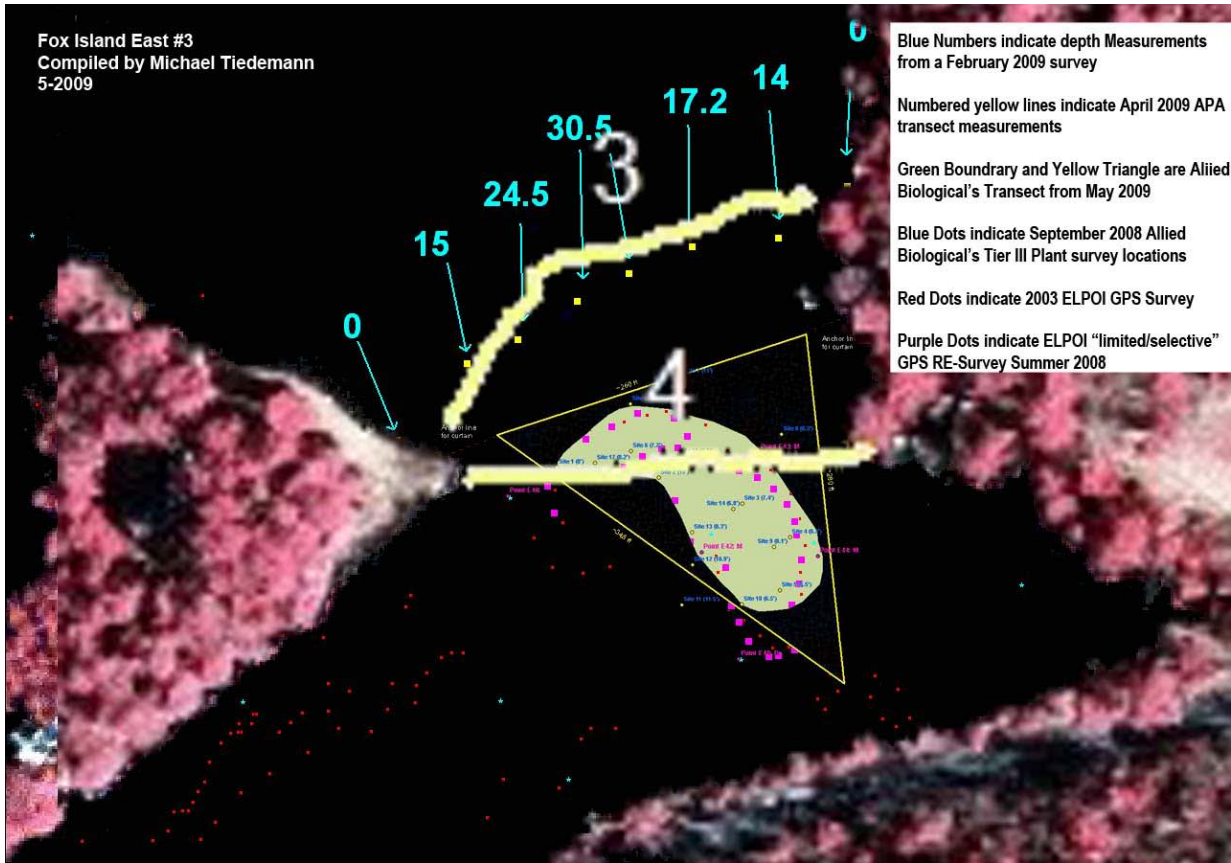
**Figure 5** Depth transect map, for one side of the bay, for the proposed site specific herbicide treatment locations. Location E, from figure 4 has been enlarged here to show depth transects from the island (west/left) to the peninsula (east/right).

- Several of the patches are located on pinnacles or sunken islands surrounded by open water with surrounding depths to 30 plus feet. Anchoring a curtain in this depth of water for several days or possibly weeks would be very difficult, if not impossible. The slopes of these pinnacles are often very steep as was found out when trying to anchor the work float. It was often necessary to have the divers locate a large rock, if one could be conveniently found, to wrap the anchor rope around as there was often nothing on these slopes to get a bite into. (Figure 5 shows a depth transect map for one of the proposed site-specific treatment locations.)

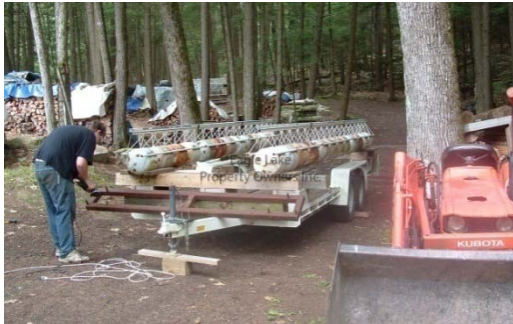
1. Constructing the work float.

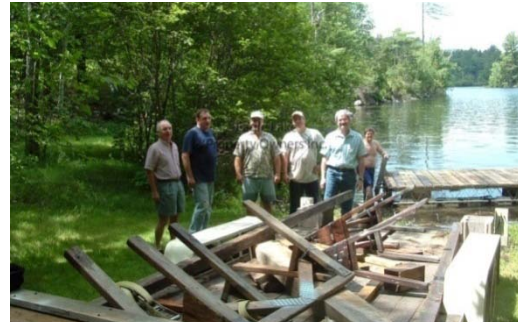
4. The launch crew lifted the float off the trailer and set it on saw horses. The trailer was removed and the float was then set down in the water.

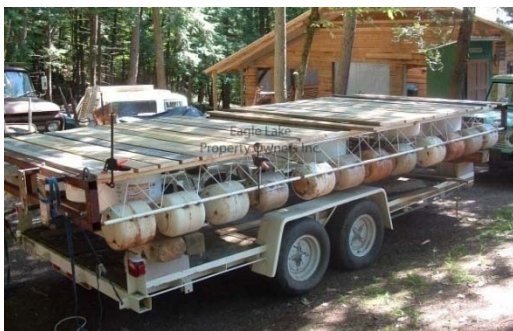
2. Work float construction almost complete.

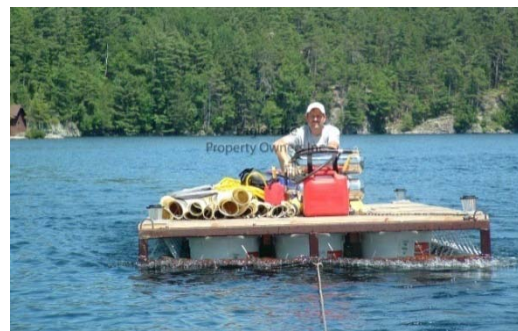
5. The work float was towed to the staging area. It worked real well for a first time boat designer/builder.

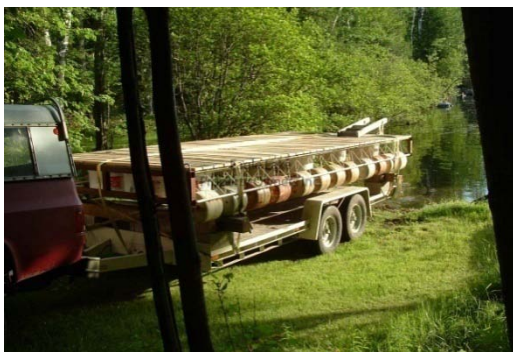
3. Work float completed and trailered 13 miles around the lake to the only private launch that could be used to put it in the water.

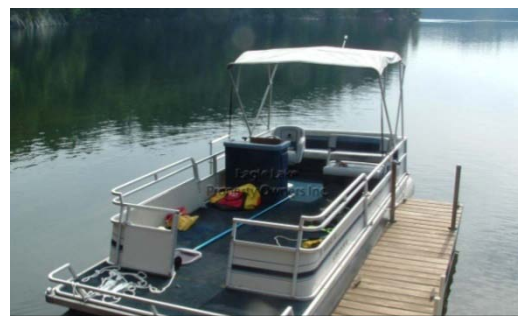
6. The project pontoon boat (donated for project use only), the work float and 2 small aluminum run-about boats provided safe and ample room for the milfoil work team and their gear. The only problem was it did not fit under the "causeway".

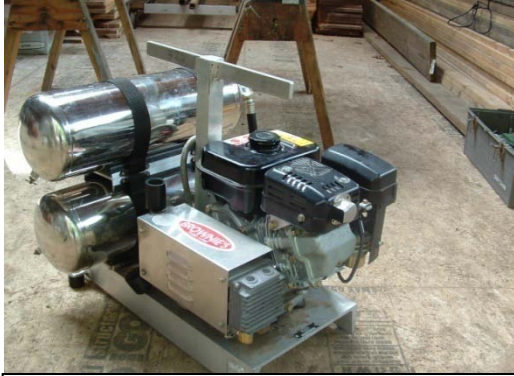
7. The hooka air compressor, expensive, but well worth it. It could safely support 4 divers and operate all day on a tank full of gas.

Lesson learned: A hooka surface air compressor, despite the over \$5,000 in upfront costs, is the way to provide dive air. The cost of its operation is minimal. Service intervals are reasonable and can be performed by a relatively mechanically competent person (the project coordinator to this project was that person). Diver body temperature regulation was at times problematic. The temperature regulation was dependent on weather sunny day vs. overcast or cool/drizzly/windy days and whether divers were at the surface receiving materials or working at depth pushing mats around. Divers were often cool on the surface during breaks on over cast days and looked for a towel to wrap up in. When pushing the mats around on the bottom, they were often warm and opened their suits to regulate temperature. Even though there was some diver temperature regulation discomfort, this part of the project presented some of the least amount of problems.

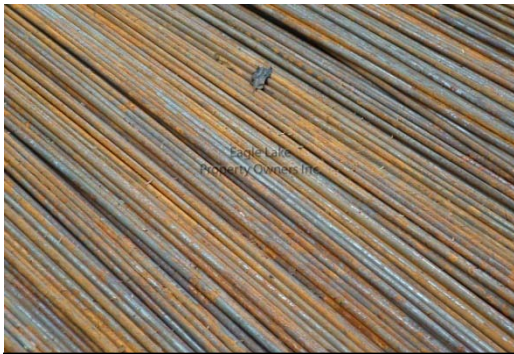
8. Steel bars and more steel bars. Pictured here, 3500lbs of 10 foot ballast hand carried from the road approximately 200 feet to the mat assembly area. In all, more than 11,000 lbs were used.

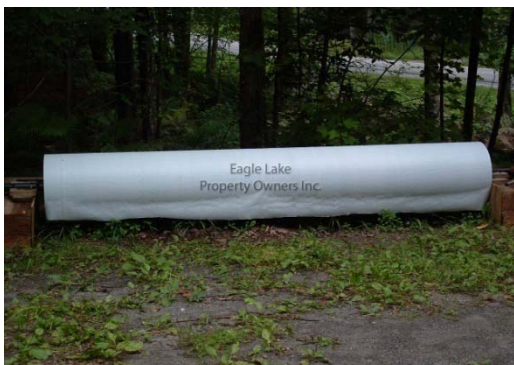
9. The 2500 lb roll of polyethylene plastic lumber tarp, 10 feet wide by 6,000 ft long, located in the only area where a tractor and trailer could unload material. Location is about 500' from the mat assembly area.

Once the mill wire supply was exhausted, an alternative mat material was searched for which required and received DEC approval for its use. This material was a lightweight poly plastic "lumber tarp", a material that is used to cover lumber when it is shipped from the mill to end

consumers. It was economical and available in a 10' by 6,000' roll, was trucked in from another state, and allowed the mat construction process to move forward once again. An additional 7,500 lbs of ballast steel was purchased and as a result an additional 38,500 sq ft of mat was assembled. Construction of mats was done predominantly by 2 dedicated seasonal lake residents. Even though they worked tirelessly on the process and a few additional volunteers pitched in, mats were placed faster than they could be produced. To relieve them of some of the work, it was necessary to hire a couple of part-time local students.

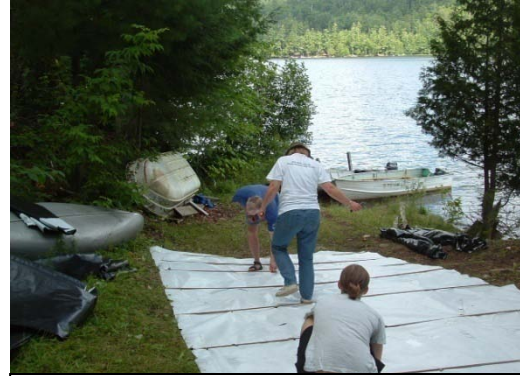
10. The mat assembly crew finishing installation of zip ties used to hold ballast to the plastic tarp (mat). Next step is to roll them up. Not a lot of extra room on this sloped work area, but better than no site.

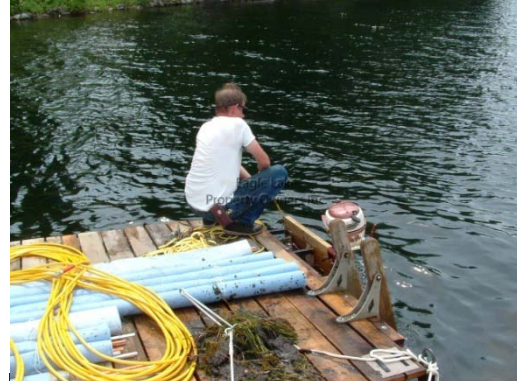
16. Setting anchor and getting ready to deploy more mats. One of the 4-150' air lines coiled up. Keeping them untangled as divers swam around was a continuous and daily chore.

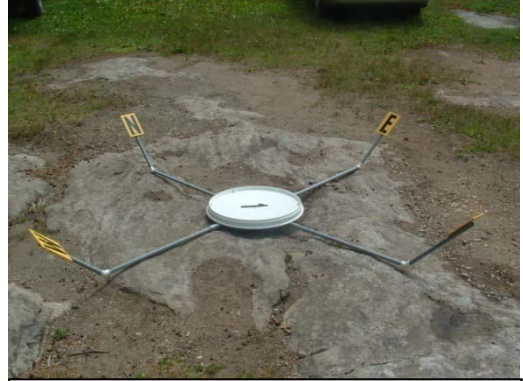
22. Underwater compass targets (shown here on land), placed in various locations in the lake, allow photos taken over time to be compared for milfoil and native spread. A Vermont DEC idea for simplifying plant surveys.

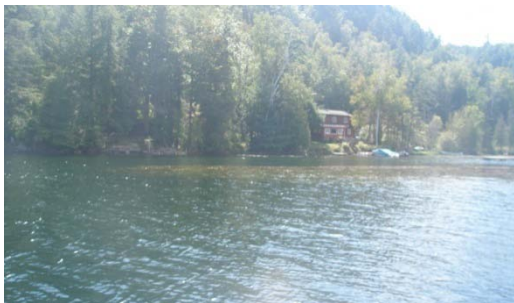
20. Milfoil “topped out” at this patch in mid Aug 2009 and remained at the surface long into the fall. It is pictured here, still visible even in late October, long after most of the natives have died back and decomposed. 2009 was a banner year for growth.

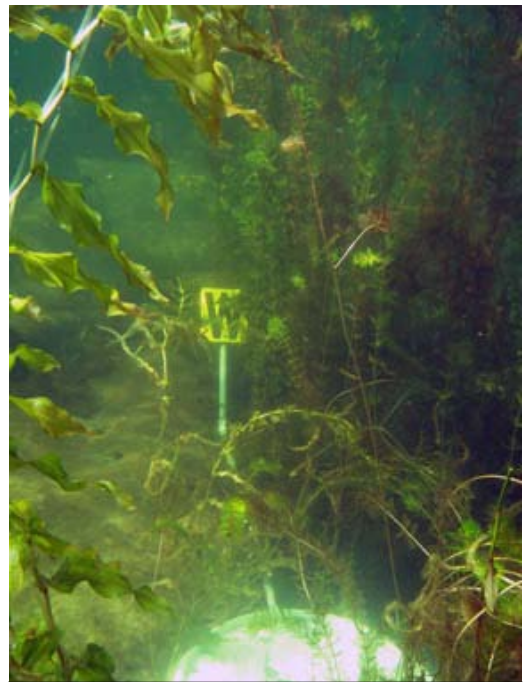
23. An in-water view of the compass target, looking west with some natives in the foreground and milfoil in the background.

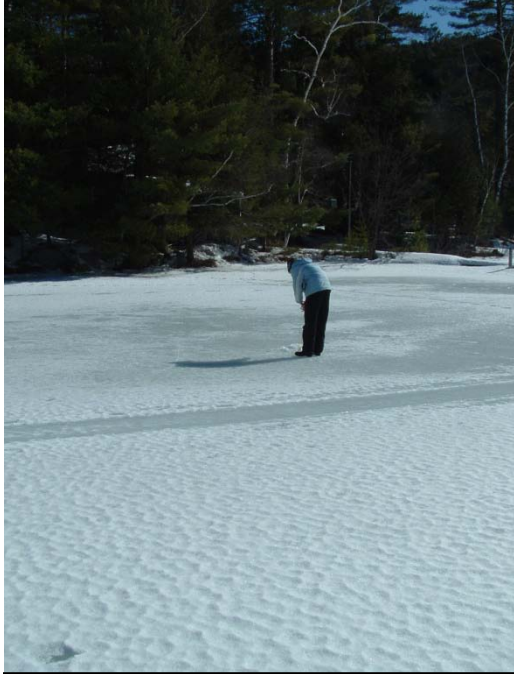
24. Making depth measurements through the ice, February 2009
