# Saratoga Lake

## Aquatic Vegetation Management Program 2008 - Year Two Report

**November 2008**

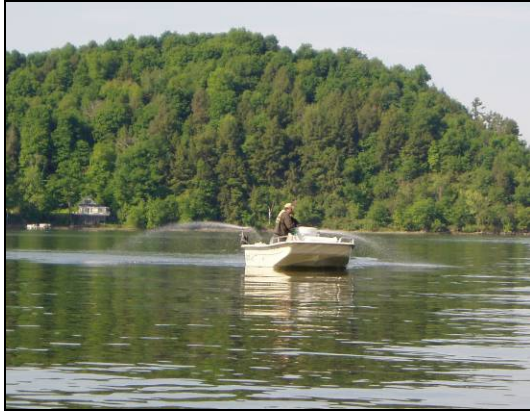
The treatment was performed using two work skiffs. Both boats were outfitted with a granular eductor spray system that fed the granular herbicide into a stream of water using a calibrated venturi-type eductor. The mixture was then sprayed off the stern of each boat through fan-jet pattern nozzles. This system allowed for the granular herbicide to be evenly distributed throughout the treatment areas as a coarse spray and the “flash-mixing” the granules with water before application significantly reduced the potential for airborne dust and off-target drift. Again both boats were equipped with Differential/WAAS GPS navigation systems to insure that the herbicide was evenly applied to the designated treatment areas. (see below)

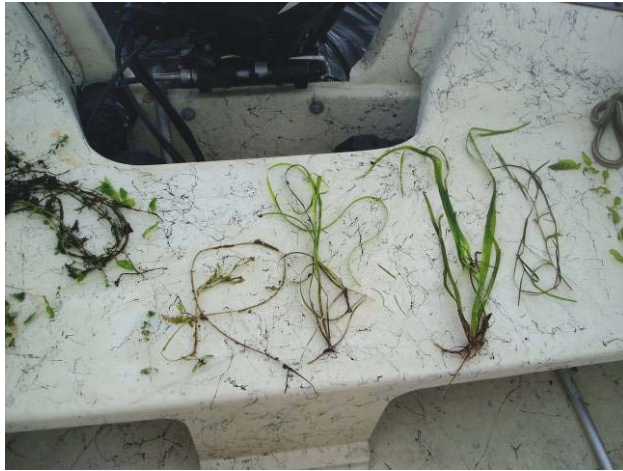
**Native plants found on 8/6/08**

Native plants appeared to be growing robustly throughout the treatment area and in all other portions of the lake. SLPID's harvester operators reported that the majority of the plants being harvested from the southern and western shorelines were native species. Plant species noted during the 11 July 2008 survey included: *Ceratophyllum demersum*, *Chara sp.*, *Elodea canadensis*, *Najas spp.*, *Potamogeton illinoensis*, *P. perfoliatus*, *P. praelongus*, *Stuckenia pectinata*, *Vallisneria americana*, and *Zosterella dubia*.

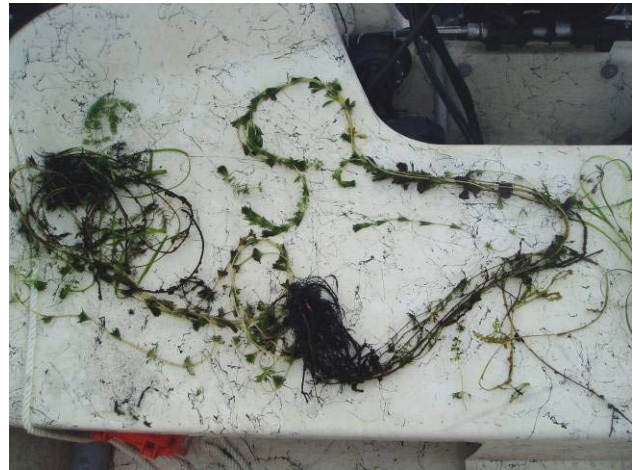
**EWM plants showing active growth on 8/6/08**

Another post-treatment inspection was performed on 6 August 2008, immediately prior to the boat tour for DEC Staff arranged by SLPID. Representatives from ACT, SePRO (the manufacturer of Renovate OTF) and the LA Group, toured the lake in similar fashion to the 11 July 2008 survey. Dr. Mark Heilman of SePRO dove and inspected the lake bottom in several locations using snorkeling gear. Observations were similar to the 11 July 2008 survey. Some widely scattered EWM plants were encountered in the treatment area and more extensive cover of EWM was found along the western shoreline.

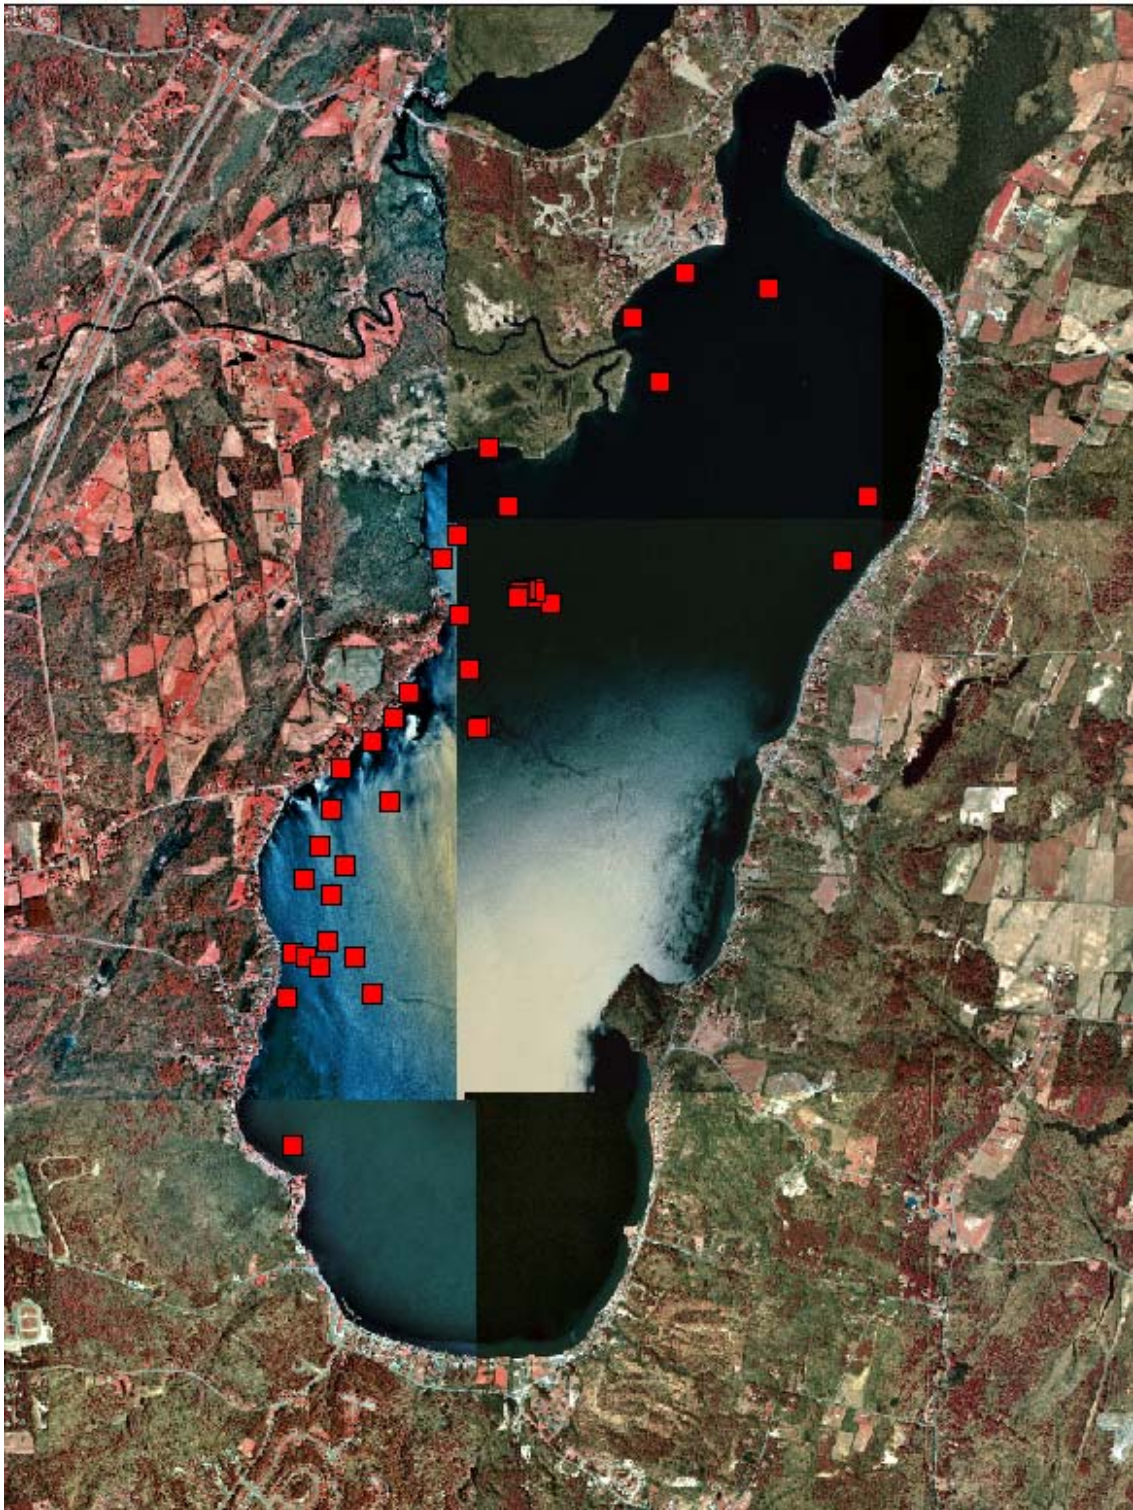
**Figure 2. Distribution of Eurasian watermilfoil (*Myriophyllum spicatum*) in surveyed areas of Saratoga Lake in 2008.**

EWM was no longer a dominant species in the 2008 treatment area, being found at only 3% of the surveyed data points (Appendix B – Figure 2). This area was designated as the “Control Area” during the 2007 survey and EWM was by far and away the most widely distributed plant being found at 80% of the surveyed data points. Results reported by DFWI for the 2007 and 2008 surveys are summarized below:
