# Lake George Milfoil Project Annual Report

# 2023

Prepared by:  
Christopher H. Sheldon, Owner  
AE Commercial  
Diving Services, INC.

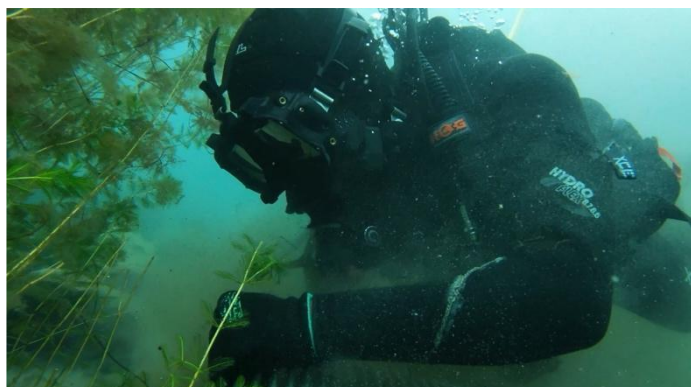
Figure : An AECDS DASH Diver begins to harvest a Eurasian Watermilfoil plant from the top down in order to reduce fragmentation and capture any parts which are already fragmented but trapped in the foliage of the plant.. Photo by Wesley Sheldon, Copyright 2023.

Diver Assisted Suction Harvesting, (hereby referred to as DASH), is the process by which SCUBA divers guide a suction hose to the area of the targeted species within a body of water and, after carefully removing the roots from the substrate, deliver the stems and root ball to the suction hose. The entire plant then travels up the length of the hose to boat on the surface where it is deposited on a table and sorted by a boat tender for disposal. DASH is an effective method to reduce and control large beds of Eurasian Milfoil to prevent it from spreading through fragmentation or seeding. AE Commercial Diving Services has developed a patent pending sorting system that allows the nutrient rich substrate to return to the bottom where it is needed to support regrowth and health of the native species. This system also delivers the material back to the bottom in such a way as to reduce large plumes of sediment from disturbing the water column.

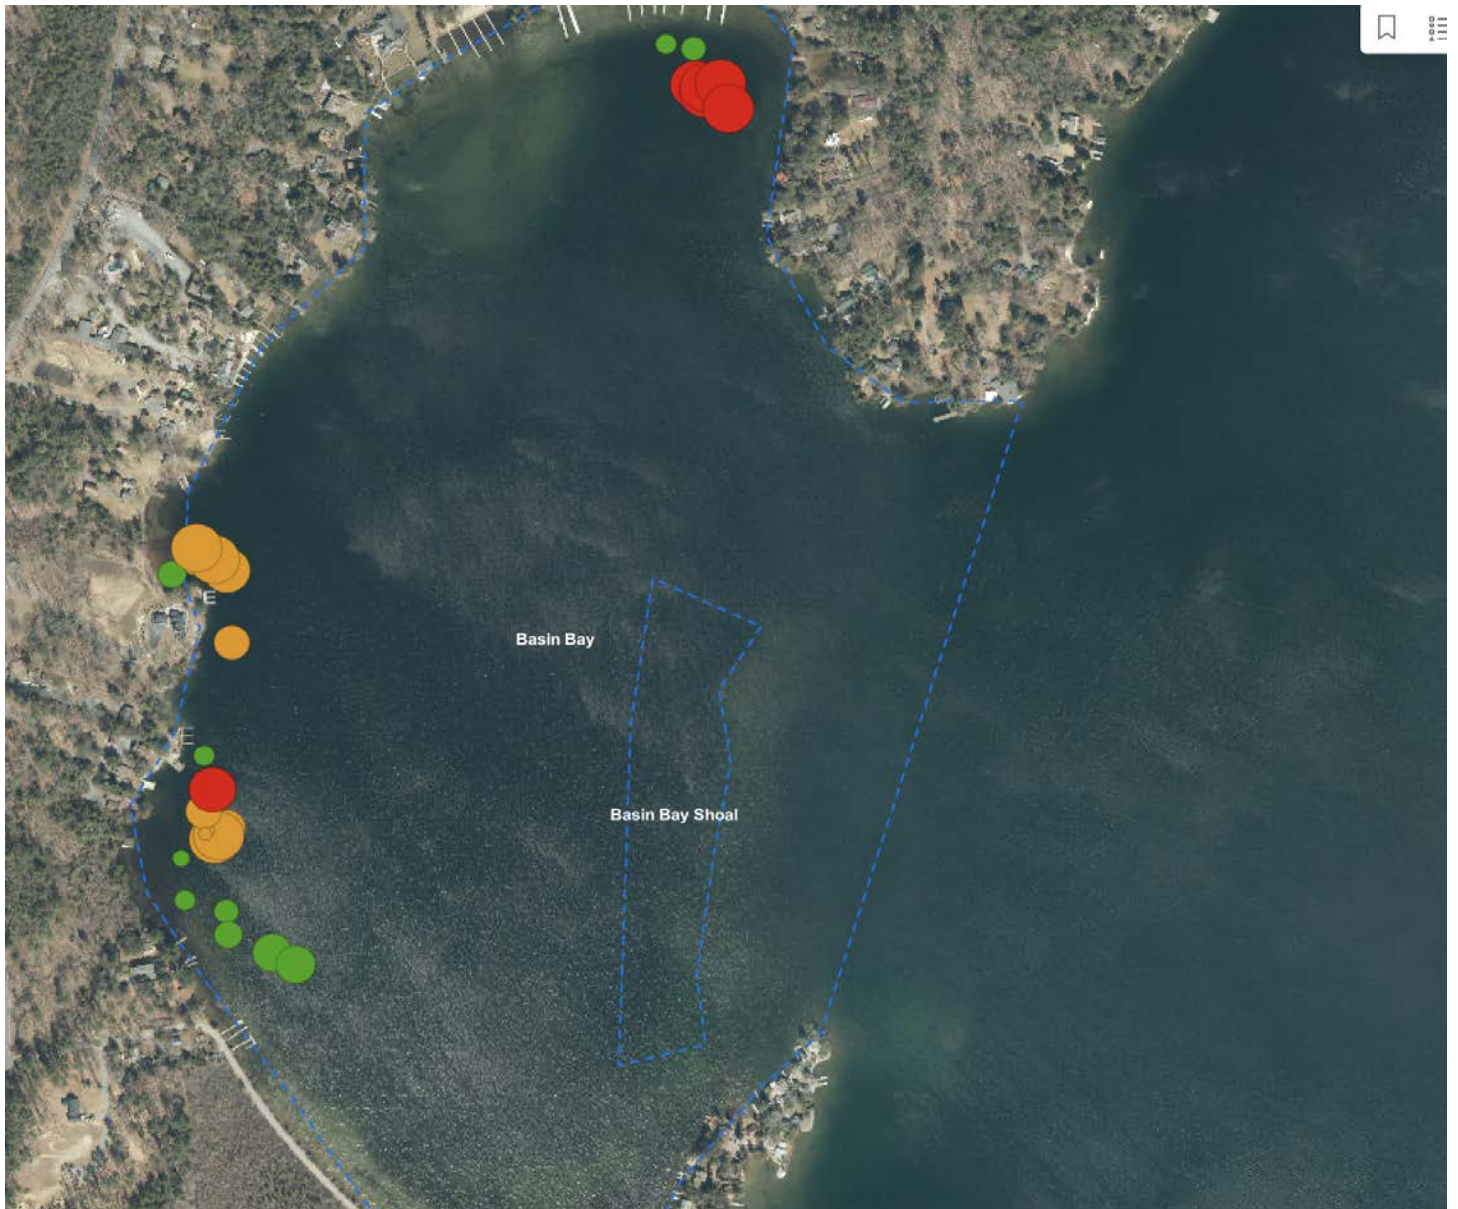
### 1. Basin Bay:

Basin Bay is a site that has shown improvement year to year, but new beds were identified and harvested in 2023 in the northeast portion of the bay, shown in red. The sites worked in 2020, 2021, and 2022 have little to no regrowth. Overall Basin Bay is in good shape. Originally the majority of the time spent harvesting was on the shoal located in the mouth of the bay. The shoal has many hundreds or thousands of milfoil plants, but we haven't harvested it because it is so rocky. Eurasian Water Milfoil migrated to new areas this season along the shoreline of the bay. These plants most likely floated in as fragments from other locations around the lake.

Overall the bay looks good now. The shape and location of the bay on the lake make it difficult for fragmentation from other locations to settle in the basin. The bay should be monitored year to year for potential growth. The new sites in the north of the bay will be managed early in 2024 to keep populations very low.

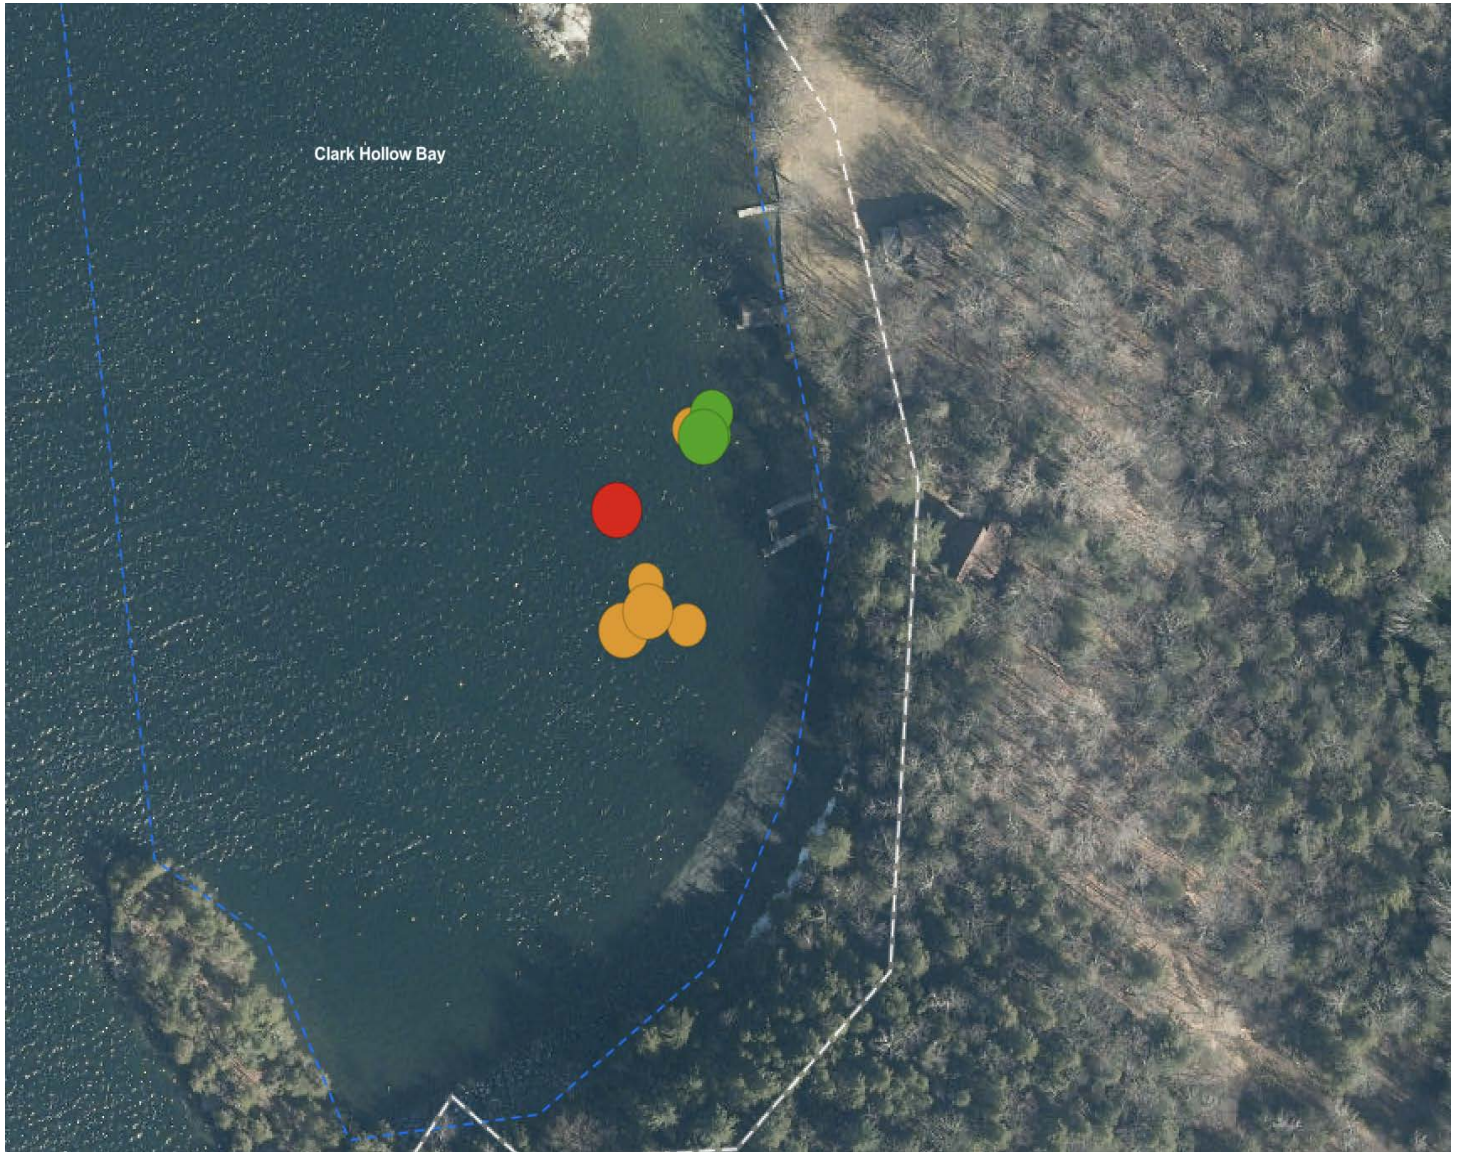
**2. Clark Hollow Bay:**

This is the fourth season of A.E. harvesting this site in Clark Hollow Bay, and it is showing slow but steady progress. This site has been fully harvested for four years. We saw about a 50% reduction in overall material removed from year 2020 to 2021 but had an increase in milfoil growth in 2022 over year 2021. As the maps show, the same areas were worked this season with an overall reduction in the amount of material removed from last year. The bay seems to be

trending in the right direction again, although this bay has been managed for many years and continues to show rebound in milfoil growth following harvest. The bottom composition in some areas is sandy which makes it difficult to remove the entire root structure of the plants which would account for the regrowth.

We recommend that Clark Hollow Bay be closely monitored for regrowth each season. We do anticipate an overall reduction in material removed next season.

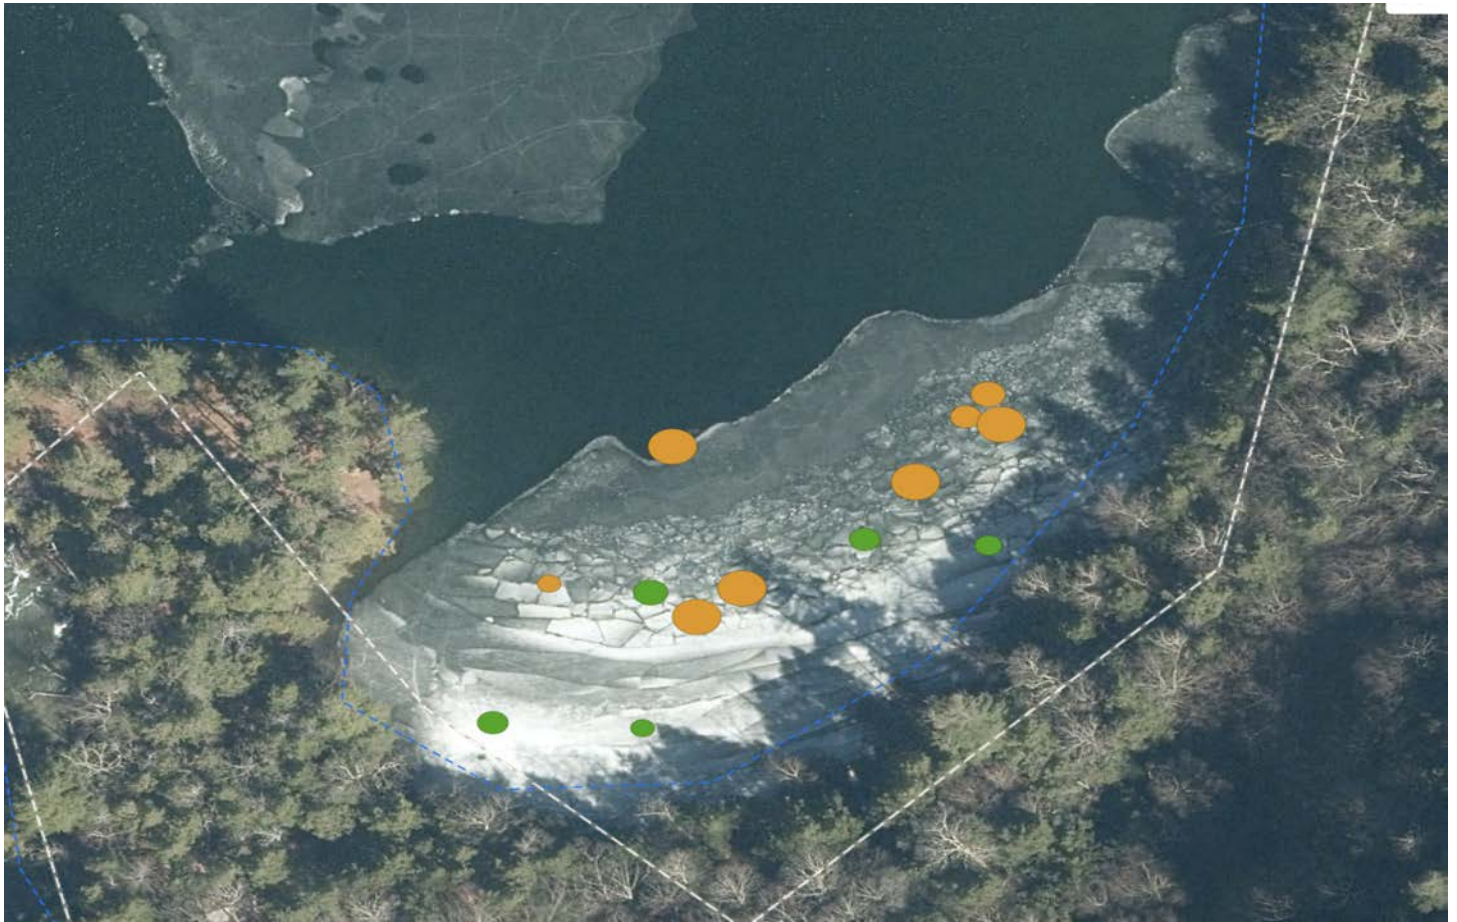
**4. Commission Point:**

In general, this bay was showing dramatic improvement over the last three seasons, with full harvest of the site each year. While the bay has been trending in the right direction, 2023 saw a slight increase in material removed. The increase in material came from a large patch located in deeper water that was not discovered until this season. Even with added material from this recently discovered patch the total material removed in 2023 is still less than 50% of the 2020 season.

This site should be monitored for regrowth each season. The area is responding well to treatment and feel that it is in a manageable situation.

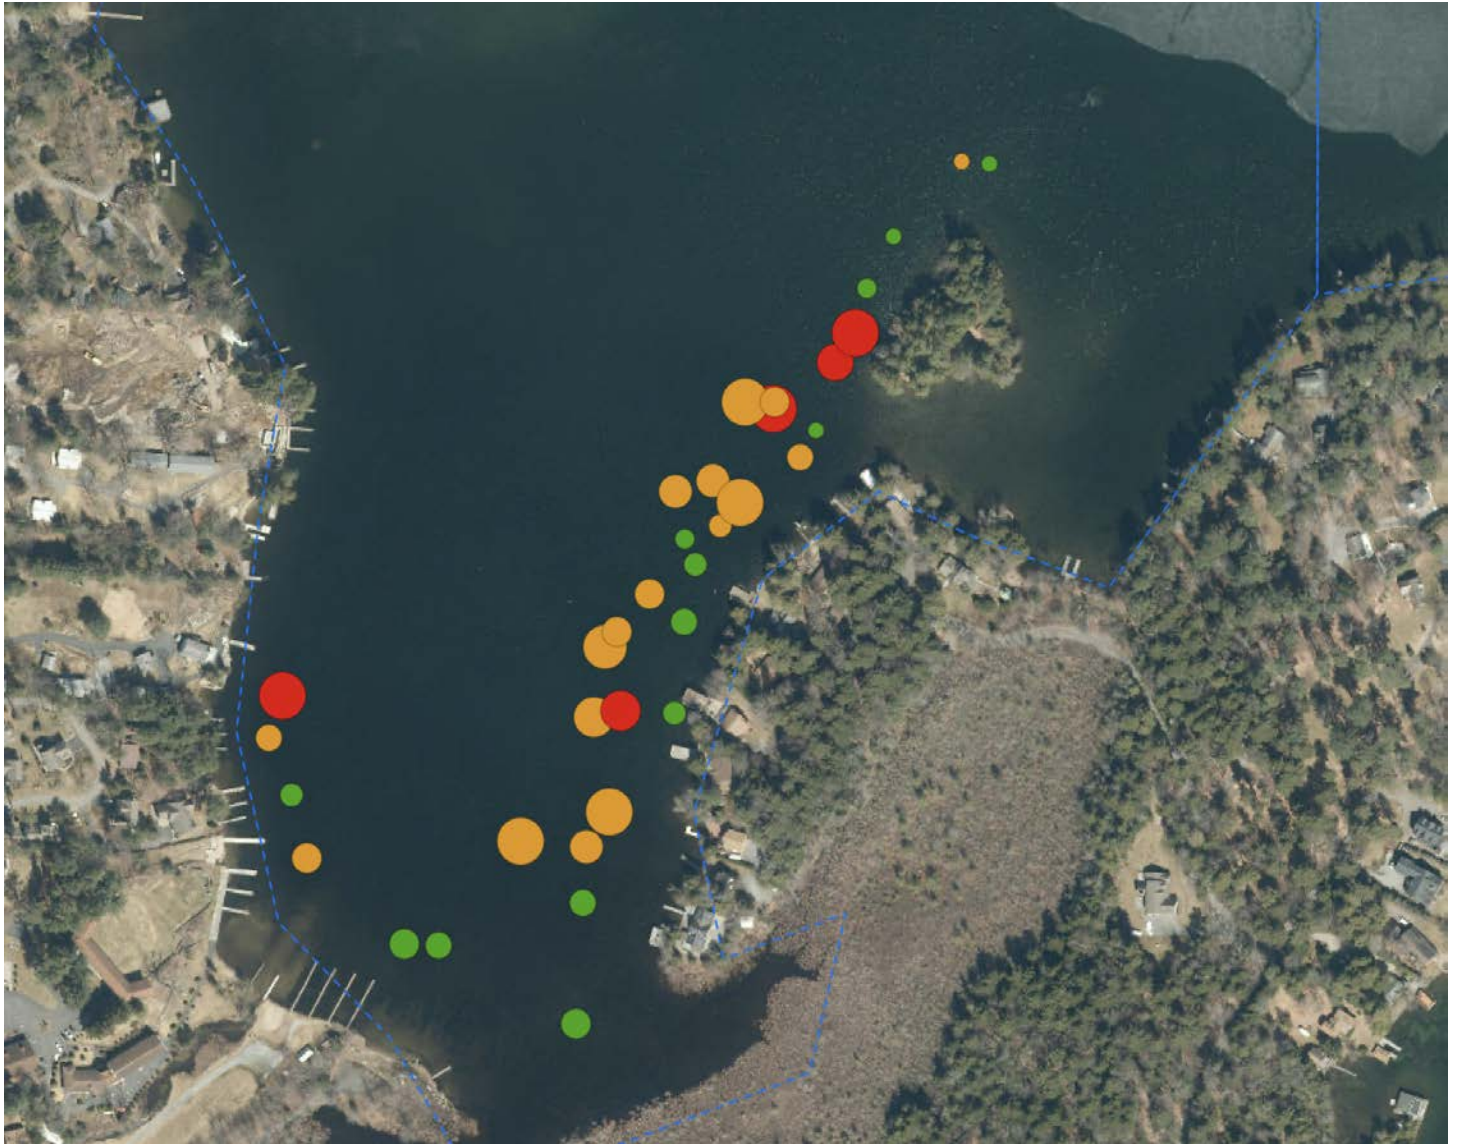
## 5. Huddle Bay:

The divers found small isolated regrowth throughout the entire bay, which also has heavy native plant coverage. Some of the isolated patches were denser than others. The EWM grows very quickly and tends to hit the surface in early summer. Huddle Bay also appears to be more turbid than other bays. This could be, in part, due to the wetlands ringing the bay slowly leaching organic material into the water column during heavy rain events. This could create a nutrient rich area for plant growth as well as low visibility conditions for diving operations. The heavy boat traffic in the bay also makes it ideal for fragmentation and dispersal. The site showed a significant increase in the amount of material removed over 2022.. This unintended native plant by-catch may be one reason material removed increased this season.

removing the whole root mass of the milfoil plants. These factors add to the poor visibility and make dive operations more difficult. Locating EWM in such a large bay with low visibility takes time and plants are missed. Therefore, the site should be harvested early each season and if possible double check later in the season.

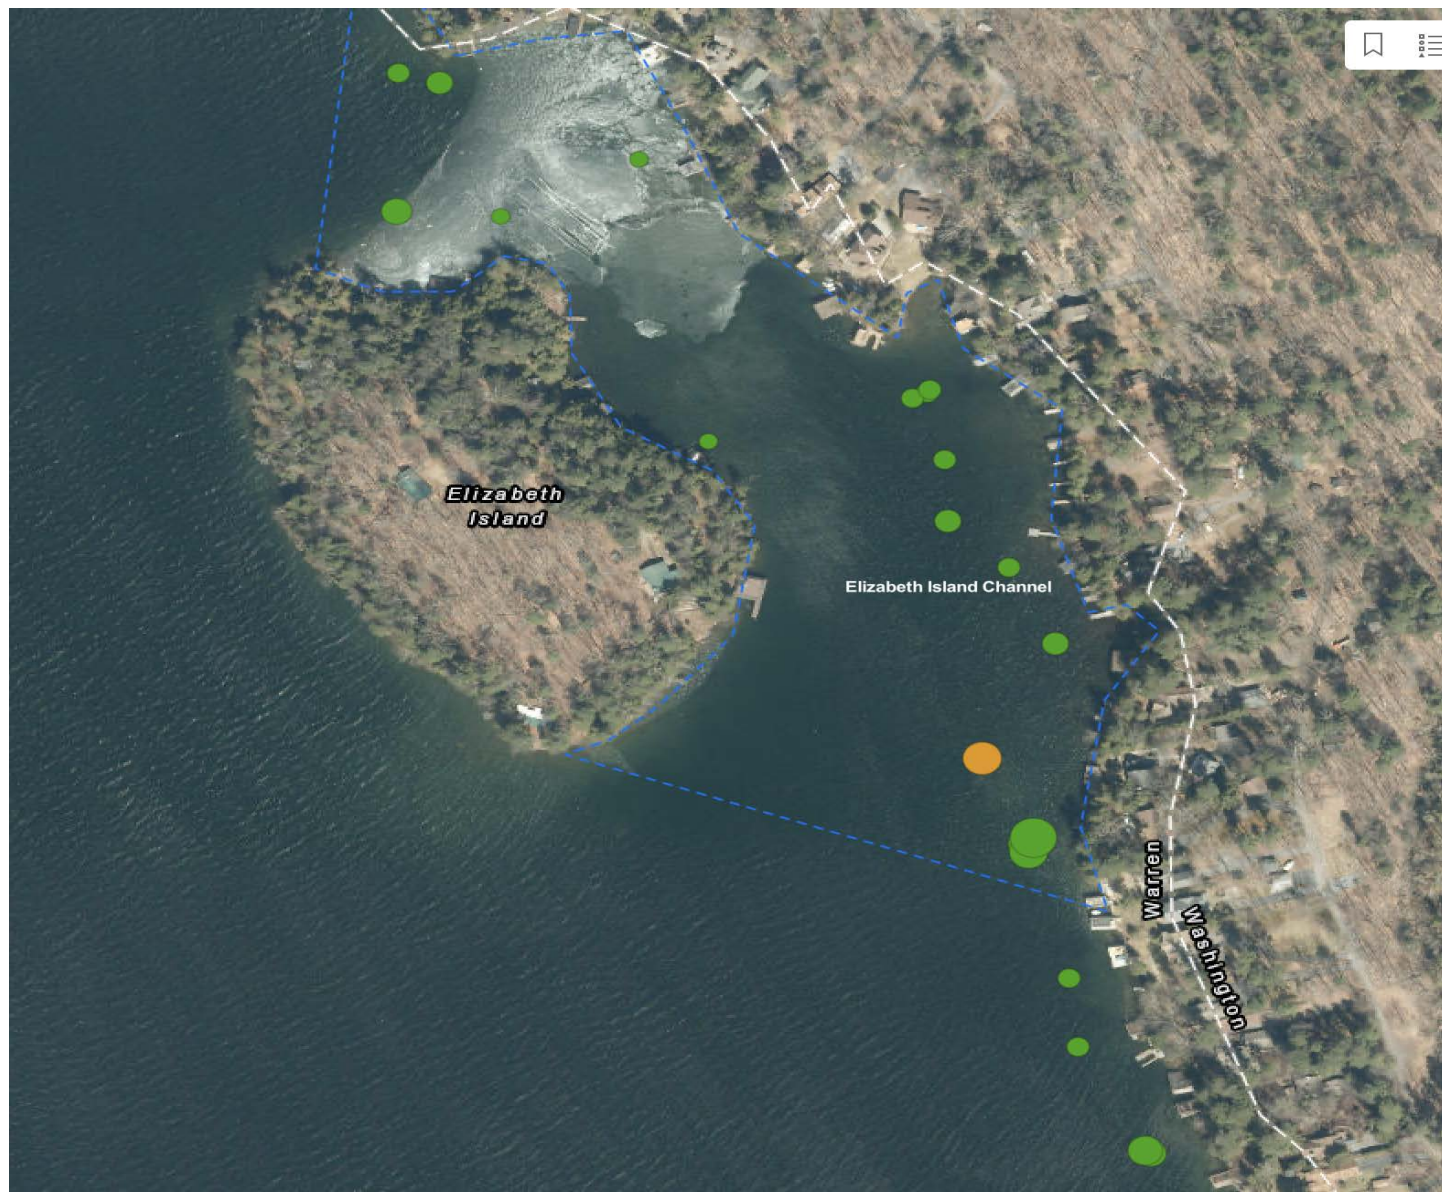
**8. Elizabeth Island Channel:**

Elizabeth Island Channel showed a significant increase in EWM from when it was worked in 2019 to when it was worked again in 2022. We returned to the channel in 2023 and found mostly

We believe this site helps seed Oakley Way through fragmentation. We recommend that this site be tackled as early in the season as possible to help avoid this scenario and to keep it trending in the right direction.

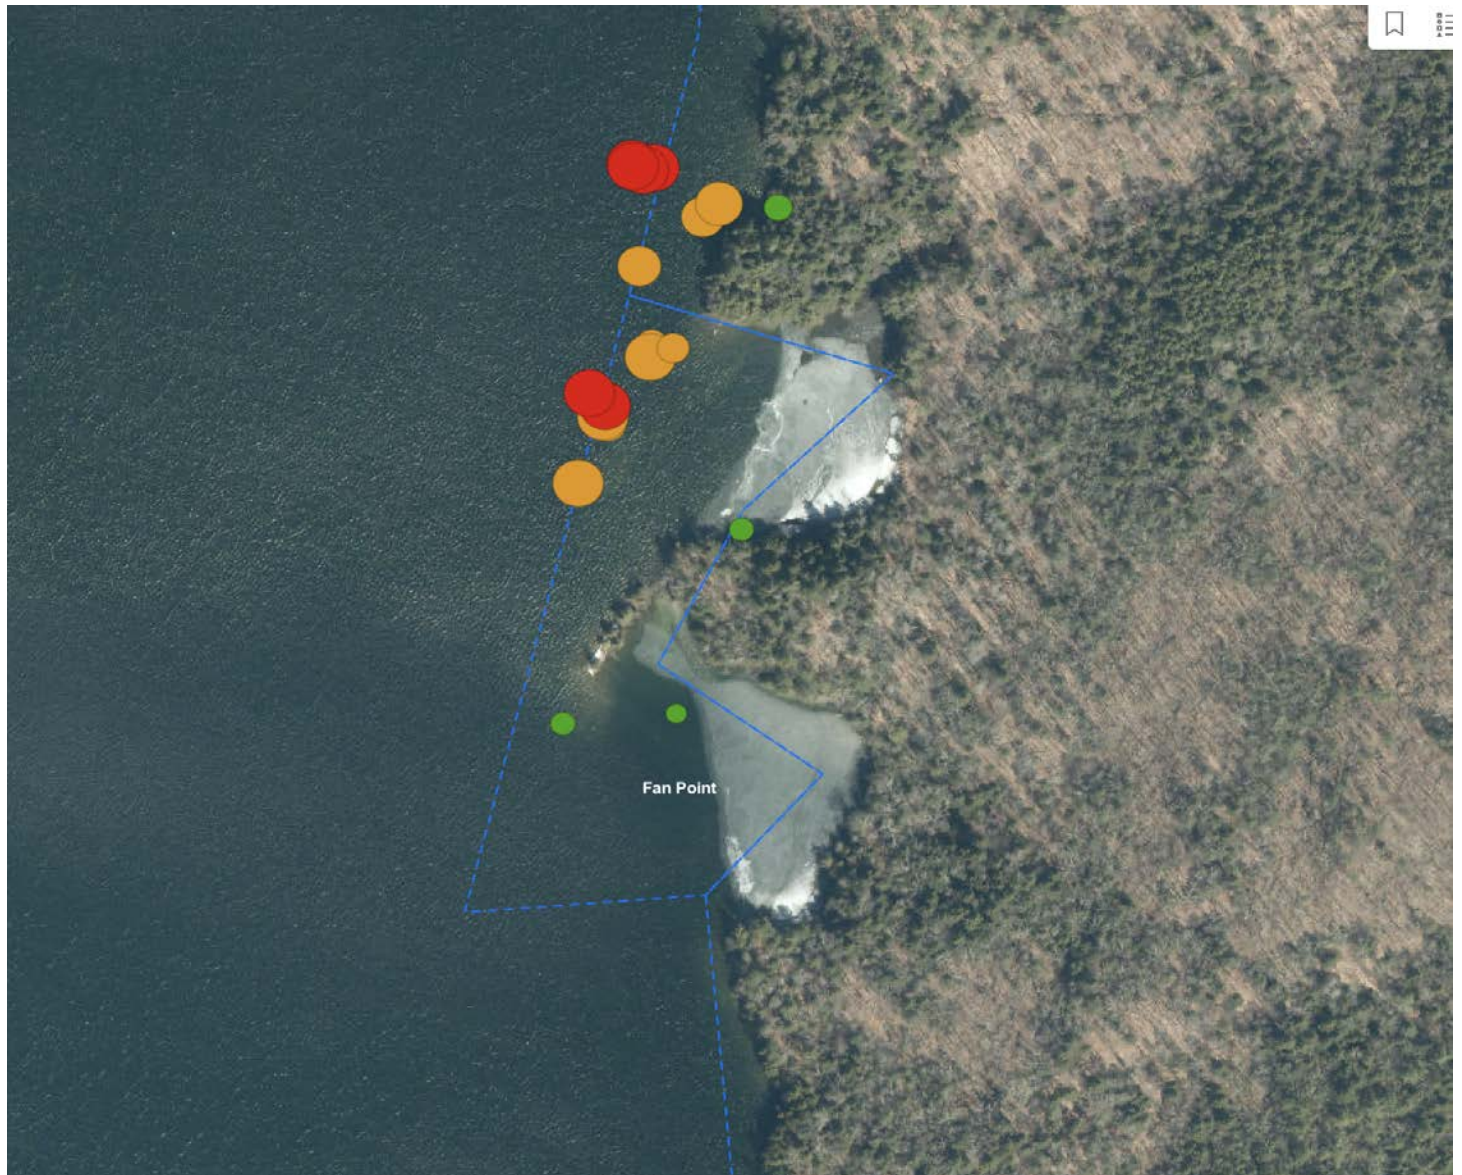
**9. Fan Point:**

This site showed an increase in the amount of EWM removed over previous seasons. An area of moderate to dense growth was found north of the point in an area not worked since 2020, in the rocky shoal area which is difficult to harvest due to roots being embedded in the rocks. The area south of the point showed an improvement over previous years with the majority of

We do not anticipate much regrowth at this site. The bottom composition in most of the site makes it easy, quick, and efficient to work. An annual survey and regrowth removal of the site is recommended so that forward progress can be maintained.

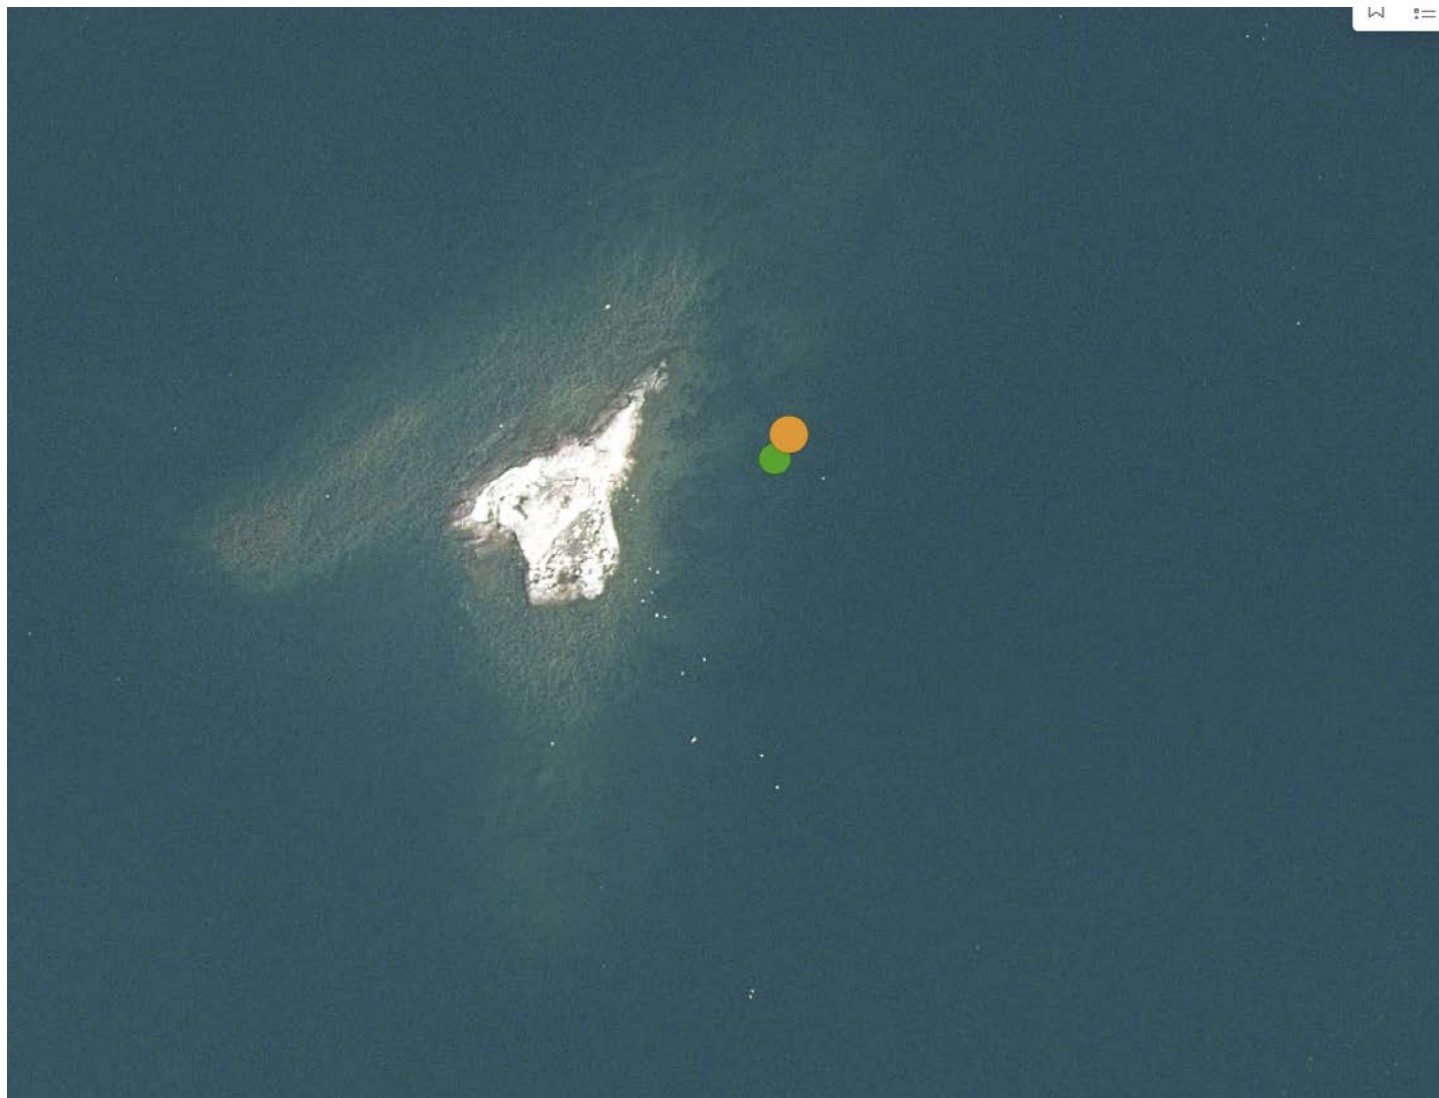
### **13. Gull Bay Island:**

This was the second season of DASH work at Gull Bay Island. Last season we found large beds of very tall, dense, multiple stemmed plants around the entire island. This season we only found sporadic growth with a dramatic reduction in the amount removed.

It is our recommendation that this site be closely monitored. It's important that this site be maintained because of its proximity to Gull Bay.

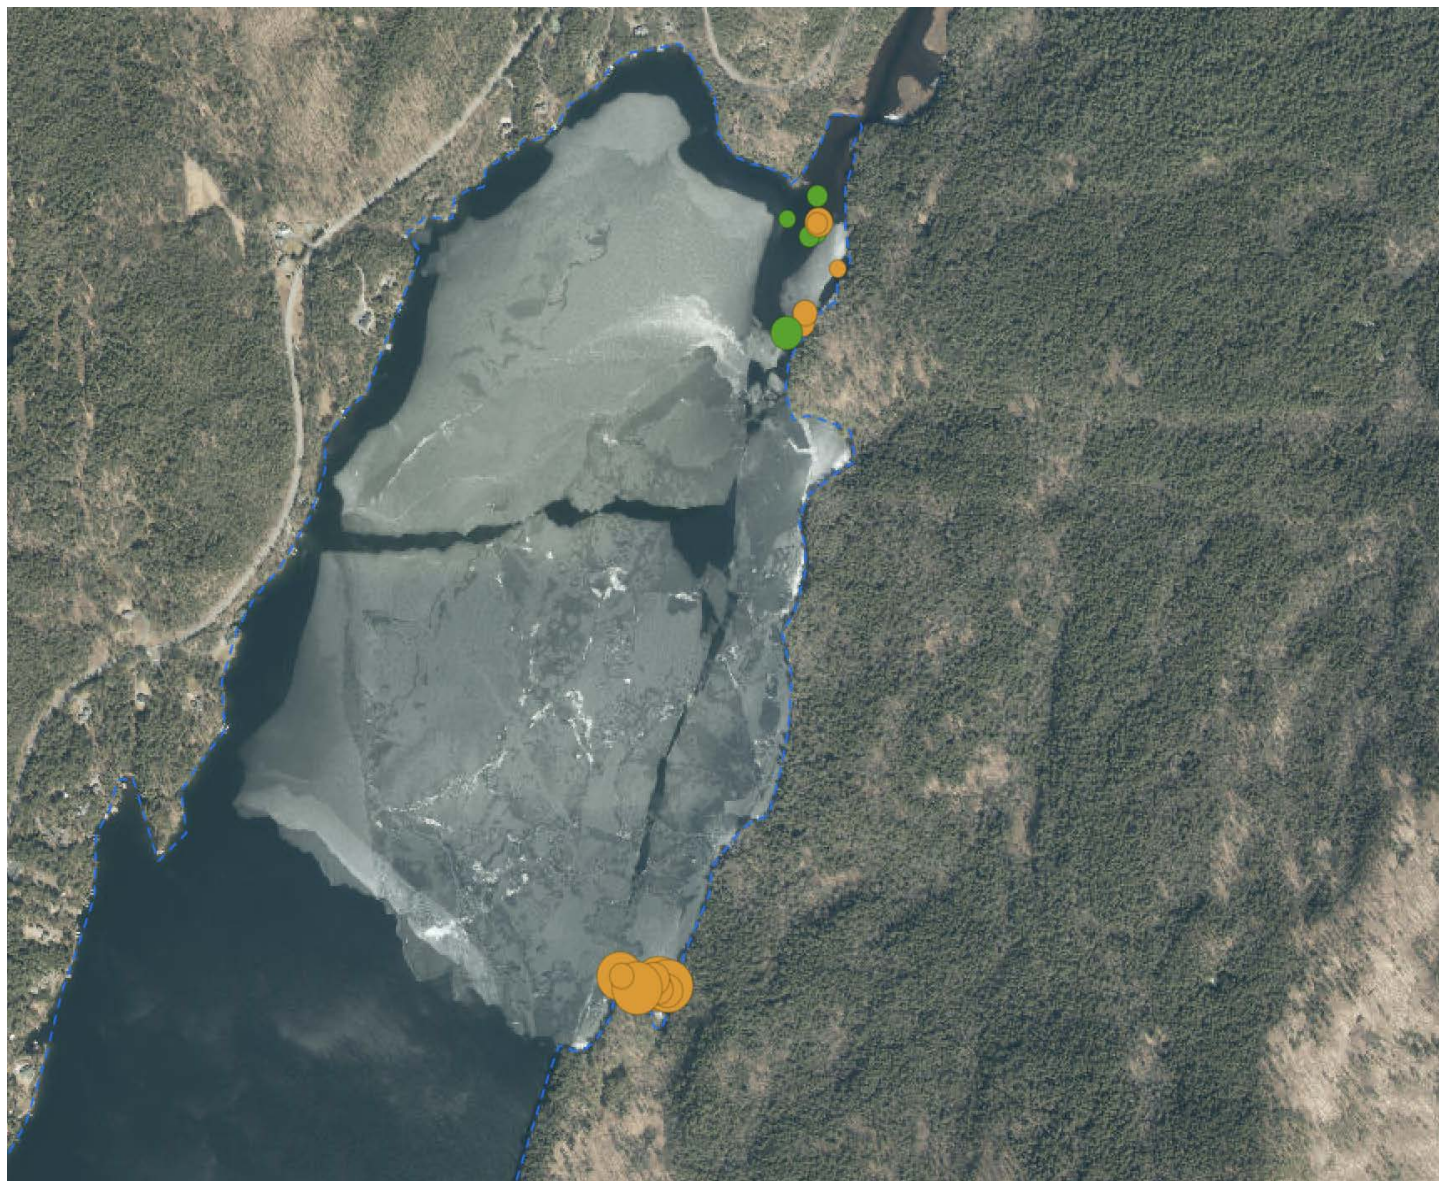
## 16. Northwest Bay:

Two sites have been harvested in Northwest Bay over the last five seasons, following up on several years of effort prior, going back into the 1980's. The numbers went down in 2022 but have gone back up a bit for 2023. A new location in the NW Bay was found last season but time and budget didn't allow us to complete the area. That area was completed this season which is why the numbers were higher. The previously harvested areas showed little regrowth and were cleaned up quickly.

We recommend an early season survey to assess the regrowth in this bay and its harvesting needs. Continued effort in the new location is needed to maintain what has been done and continue the positive trend.

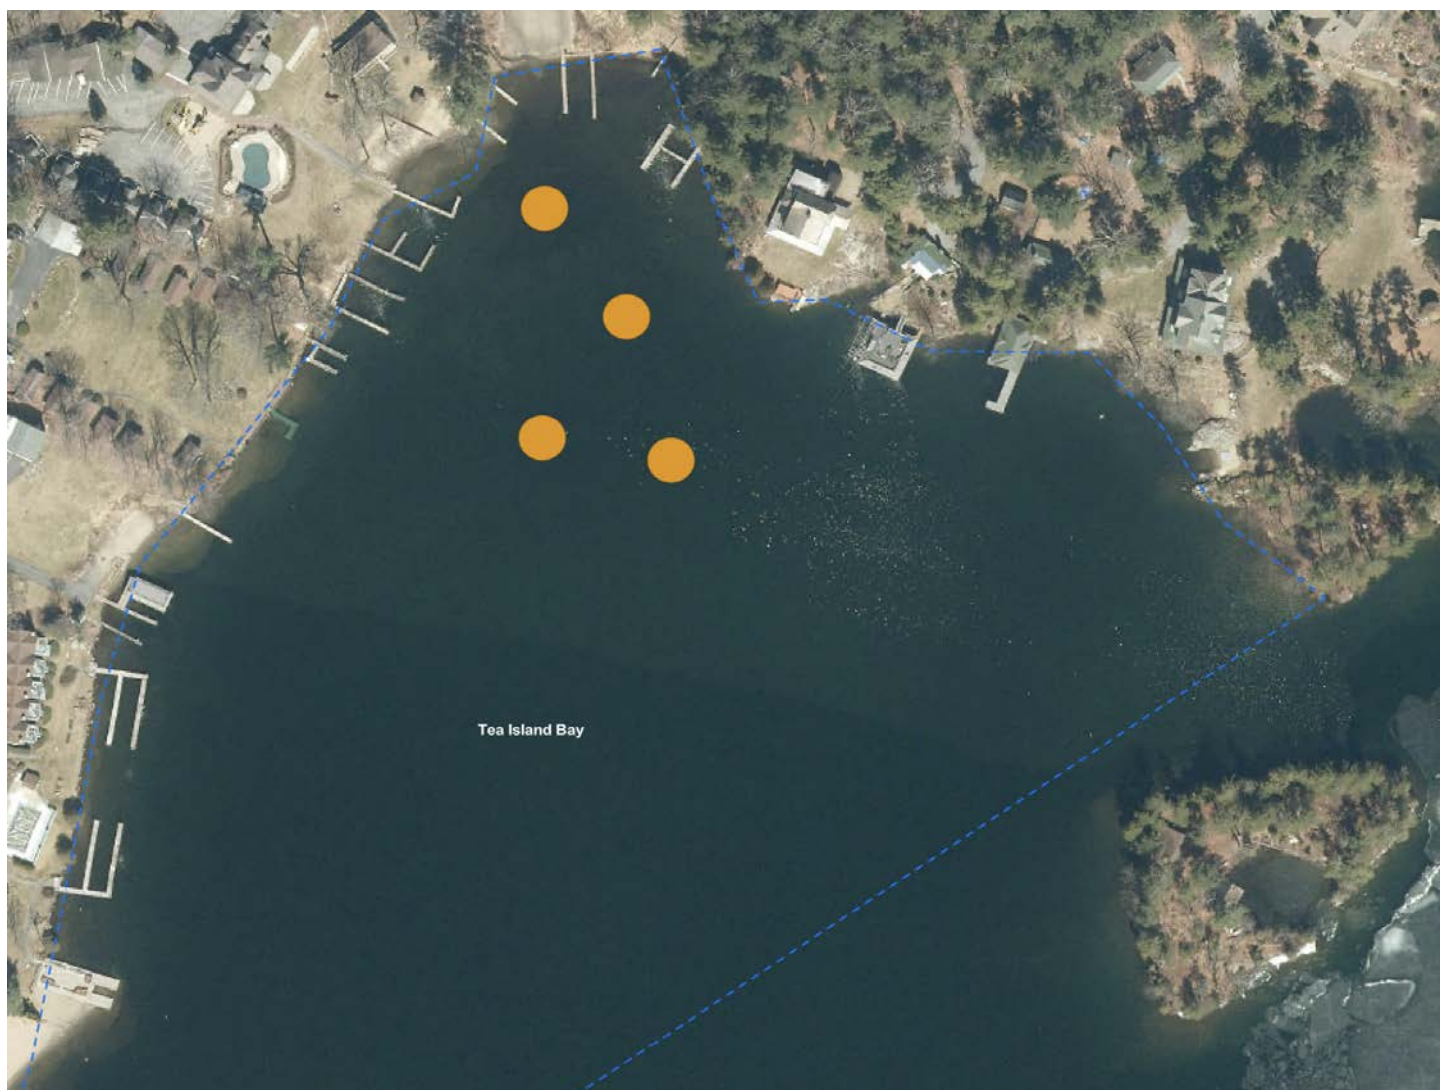
## **19. Tea Island Bay:**

The Tea Island Bay continues to be a work in progress and fewer sites in the bay were located in 2023. They consisted of small, moderately dense, beds of Eurasian Watermilfoil in the center of the bay and were easily cleaned up. As in years past, these beds were found around barren lake bottom where the bottom barriers were removed in 2020. These areas are slowly filling in with native plant growth, but some Eurasian Watermilfoil remains. This area is challenging to work because of the depth of the water, boating activity, and the abundance of native plant life. The total removed from this site includes a considerable amount of unintended native by-catch.

This area should be checked again in 2024. However, we feel it should be done early in the season if possible to avoid the boat traffic and reduce fragmentation.

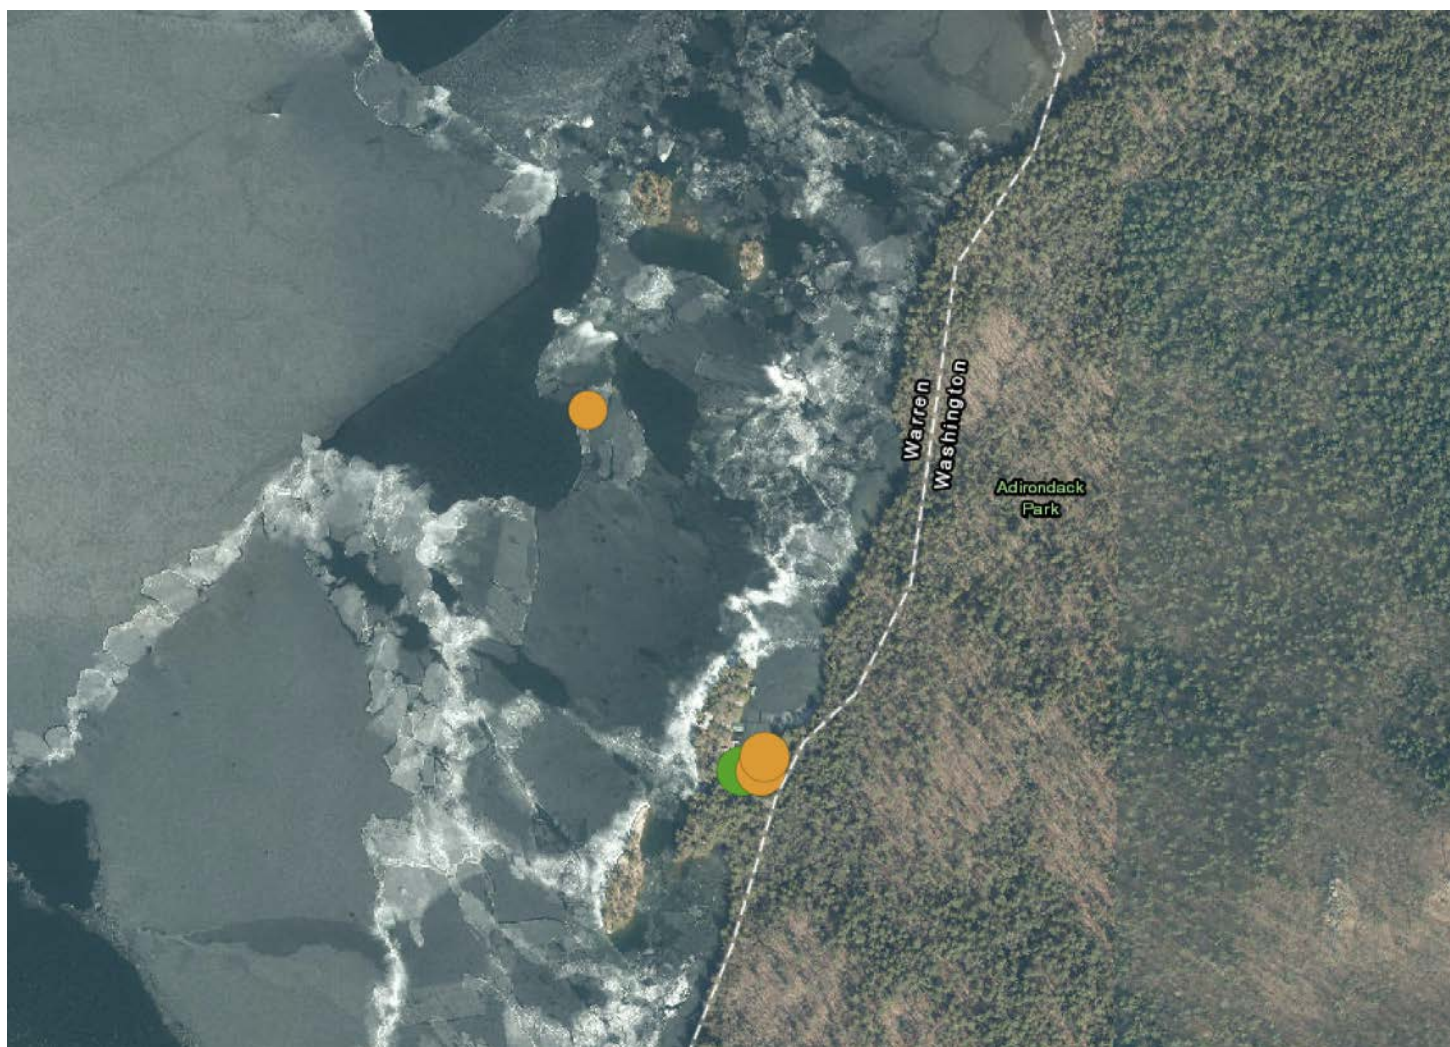
## 20. Lynden Point:

The Lynden Point site continues to be a work in progress and the numbers year to year are relatively consistent. A few, small, moderately dense, beds of Eurasian seem to show up in basically the same location every year. These beds were found in 2021 and continue to linger. Eurasian Water Milfoil fragments are often noticed floating in the bay suggesting that the bay might be collecting fragments from other sites or there is an undiscovered bed of EWM near the bay.

This area should be checked again in 2023. However, we feel it should be done early in the season if possible to avoid the boat traffic and reduce fragmentation.

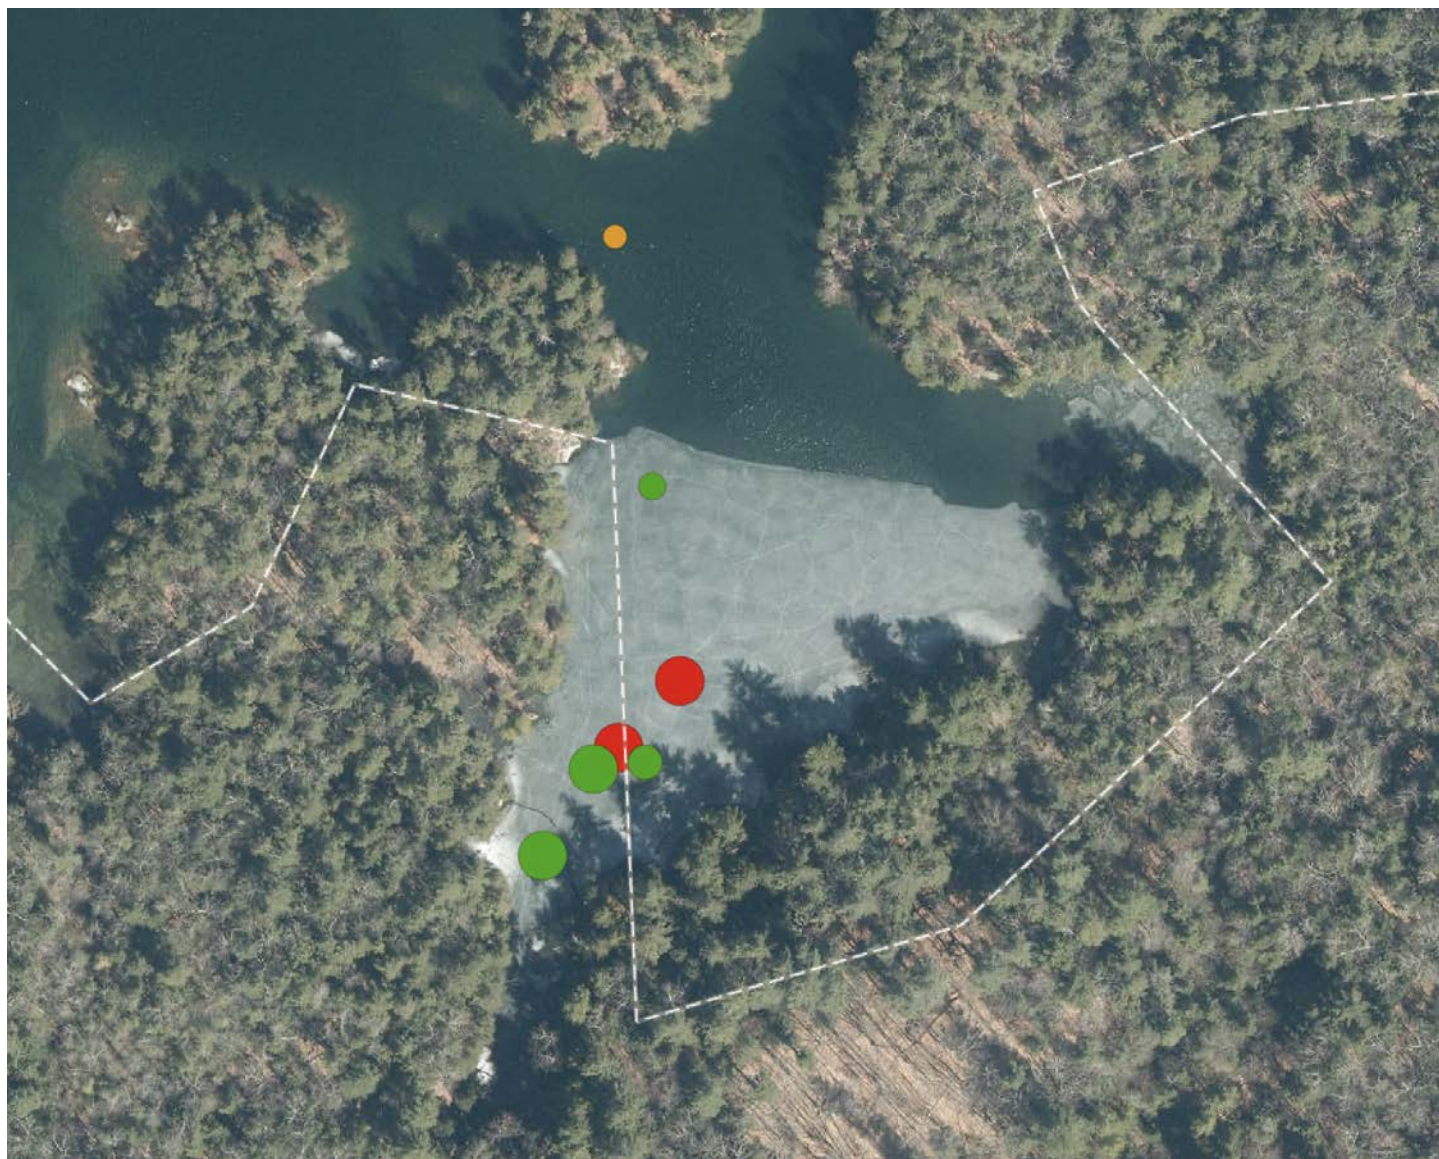
## 22. Paradise Bay:

This is the fourth year of harvesting in Paradise Bay, clearing the bay of known milfoil each year. The first bed of EWM found in the bay was located deep in the bay. Last season that bed seemed to move north by was much smaller and less dense. This season the regrowth was located in the same area but was larger and had a few lighter density beds around it in the immediate area. The site was quickly cleaned up. We anticipate a reduction next year in the amount removed.

We recommend an early season survey to determine the level of effort needed to maintain the site and get it back into a downward trend.
