Lake Morey

Aquatic Vegetation Management Program 2007 – Year One Report

Final Version: December 11, 2007

**Aquatic Control Technology, Inc.
11 John Road
Sutton, MA 01590**

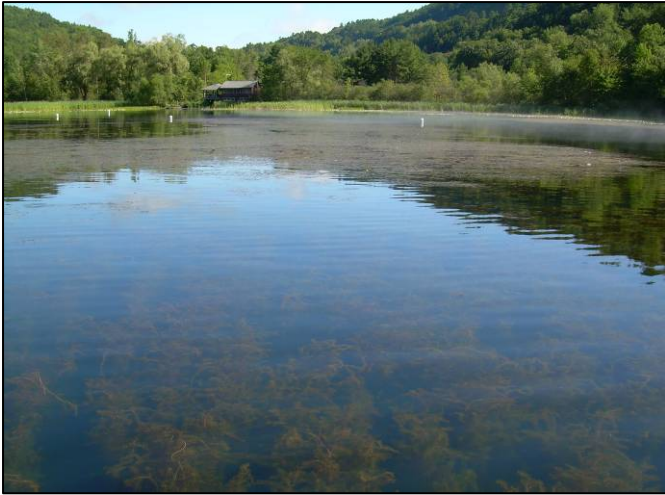
North End – Pre-Treatment August 2006

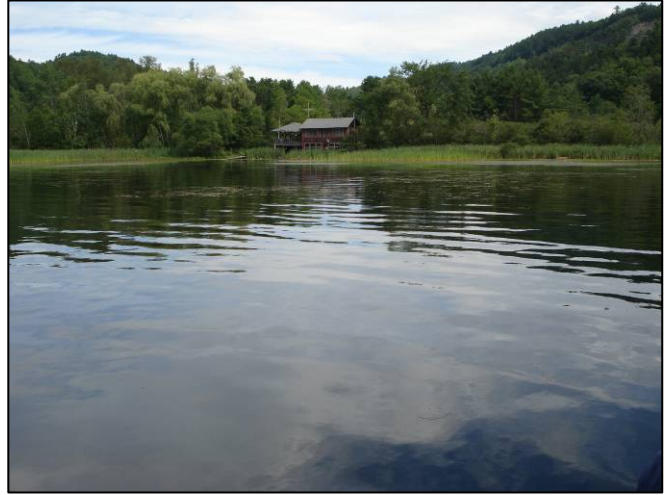
North End – Post-Treatment August 2007

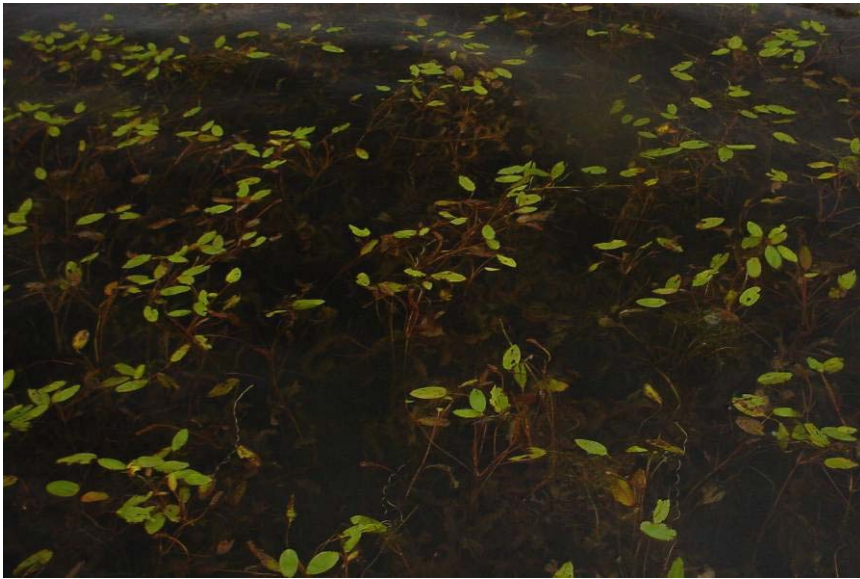
Pondweed (*Potamogeton spp.*)
growth at the north end in the
Site A north end - Renovate 3
treatment area (8/23/07)

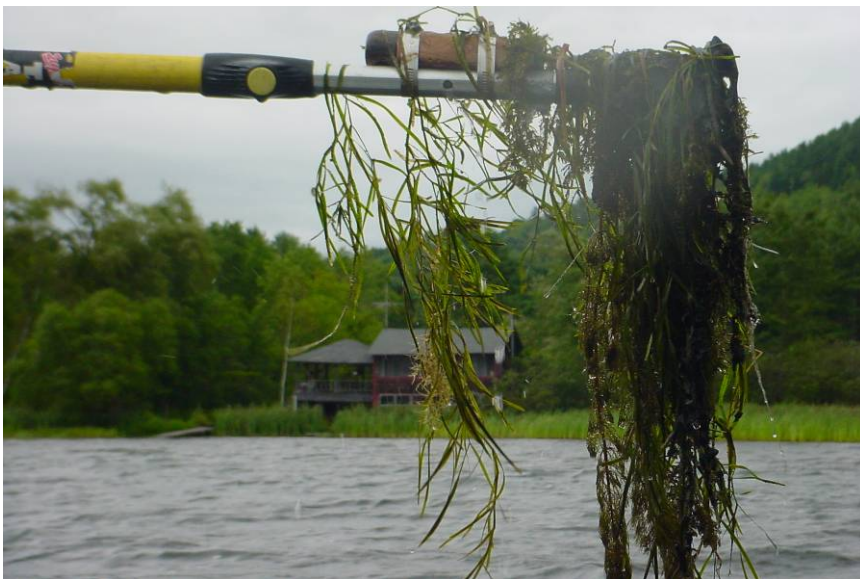
Native plant growth found in
the Site A north end -
Renovate 3 treatment area:
Potamogeton zosteriformis,
Najas flexilis, *Ceratophyllum*
demersum (8/23/07)

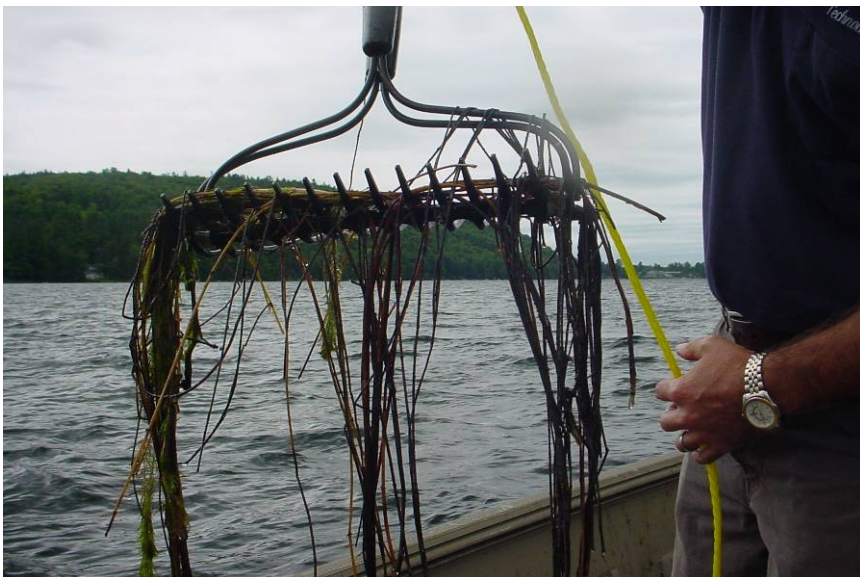
Stripped milfoil stalks found
along the deep edge of Site B
northwest corner - Renovate
OTF treatment area (8/23/07)

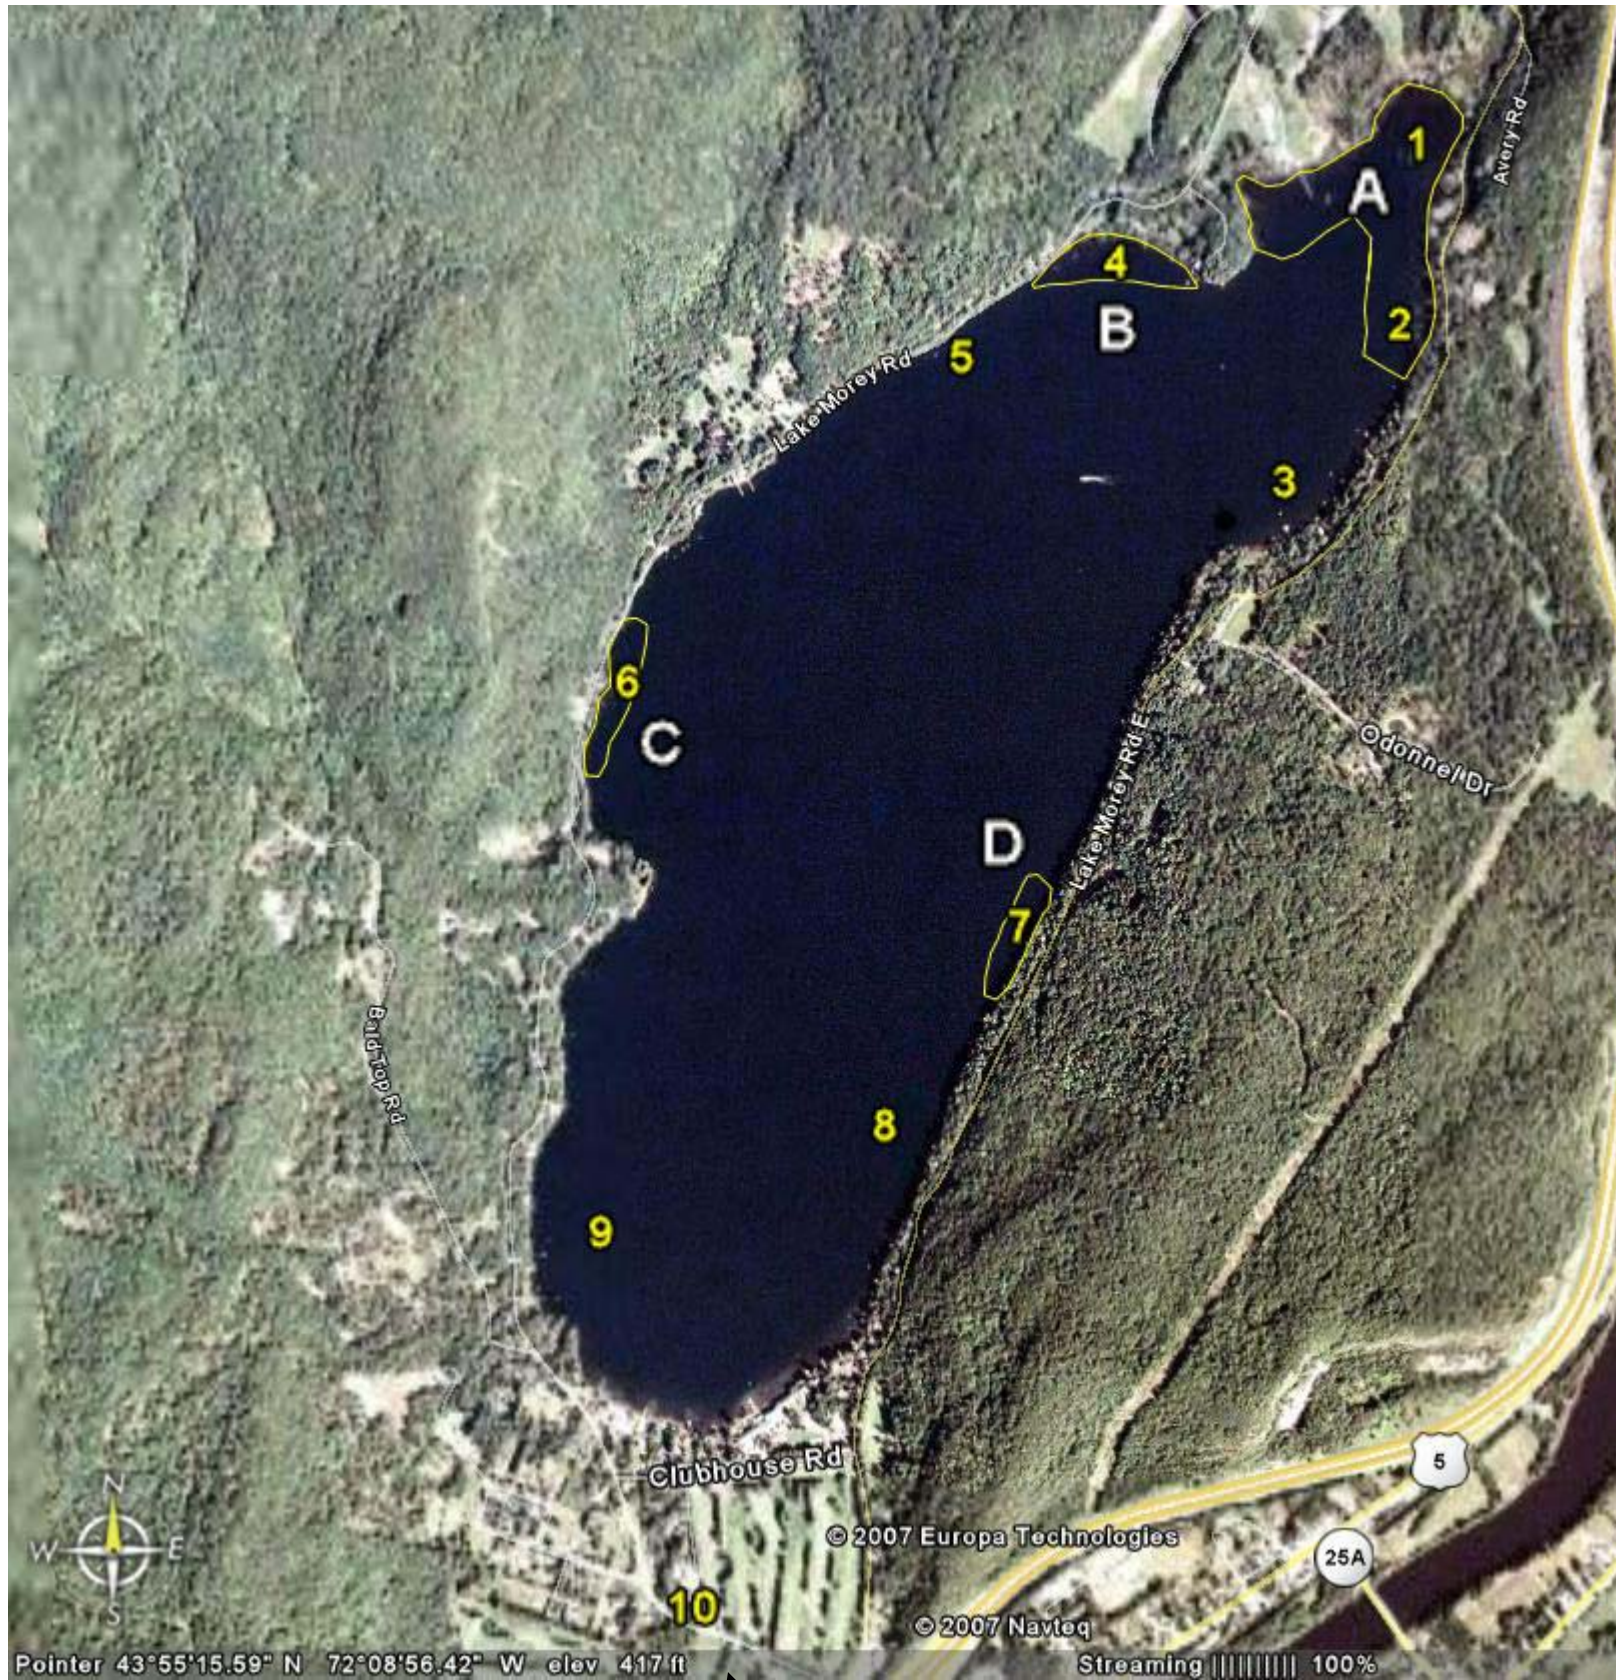
2007 Lake Morey Renovate Water Sampling Locations (Sites 1-10)

Note: Sample Station 10 is located in the outlet stream at Lake Morey Road.

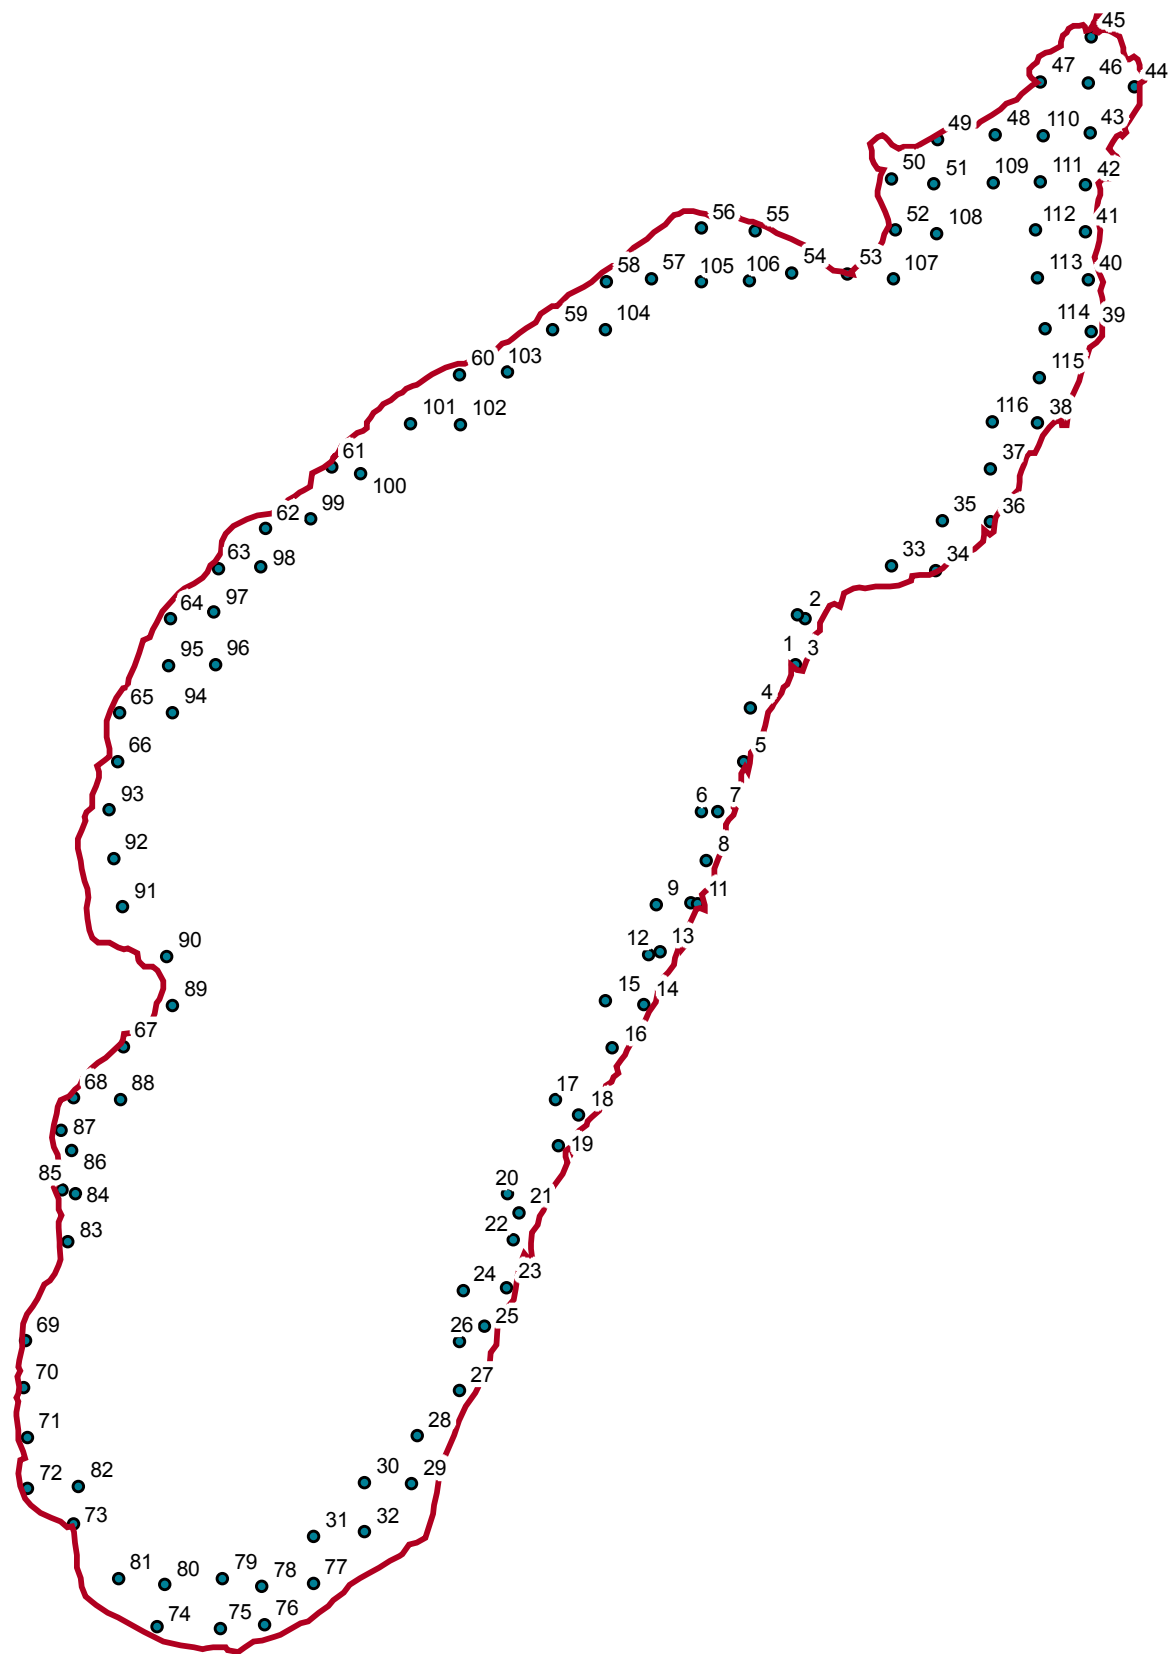
Data Point Location Map

A total of 116 data points were generated based on an 80 meter grid throughout the littoral zone (Figure 1). The depth range of the sampled data points ranged from 2 to 34 feet. Distribution of the data points by depth was fairly uniform.

- Recorded DGPS survey point locations
Same points sampled during
2006 and 2007 surveys
